## **SPECIFICATIONS FOR ASBESTOS ABATEMENT**

**OLD GALLMAN SCHOOL  
540 BRANTLEY STREET  
NEWBERRY, SC**

**CRE Project #: PD24-1120-24513**

Hazardous Materials Assessment Report  
Gallman School  
540 Brantley Street  
Newberry, South Carolina  
S&ME Project No. 22610550R.1

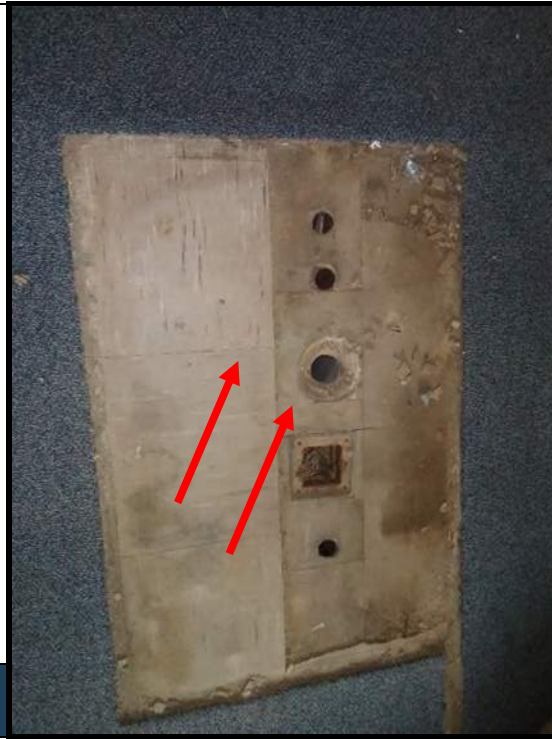
3 12-inch dark tan vinyl floor tile and black mastic and 9-inch brown vinyl floor tile and mastic tested positive for asbestos (3% chrysotile).

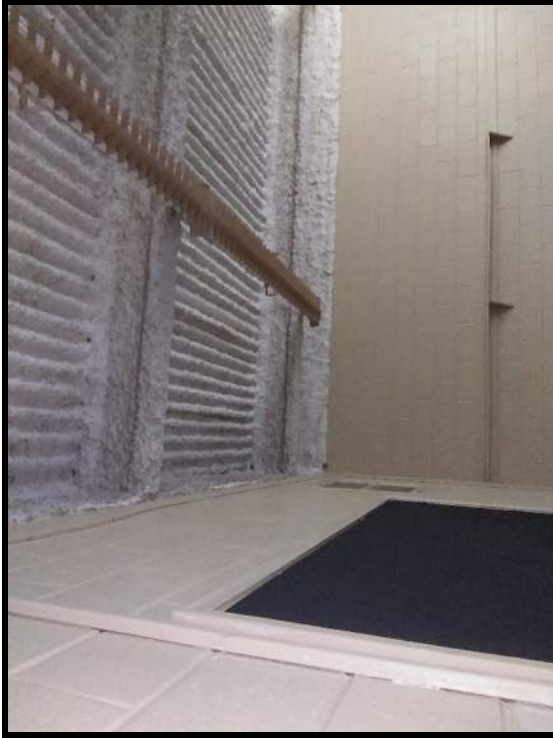
2 Spray-applied fire proofing tested negative for asbestos via PLM analysis.

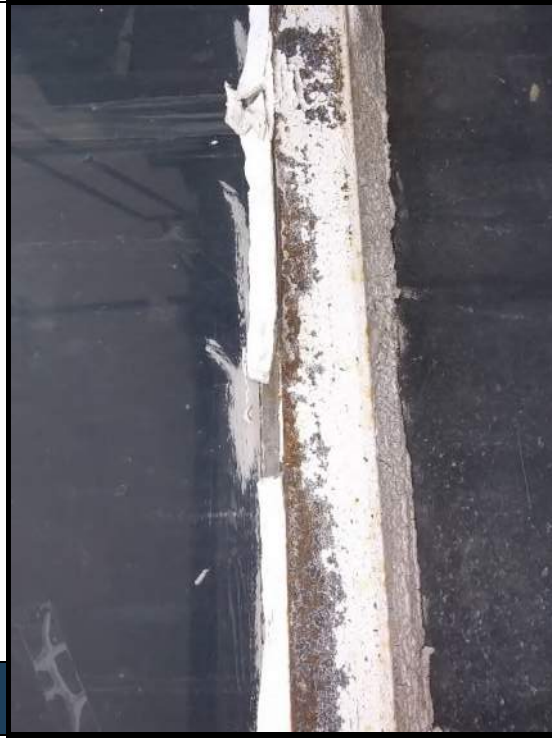
4 Window glazing tested positive for asbestos (2% chrysotile).

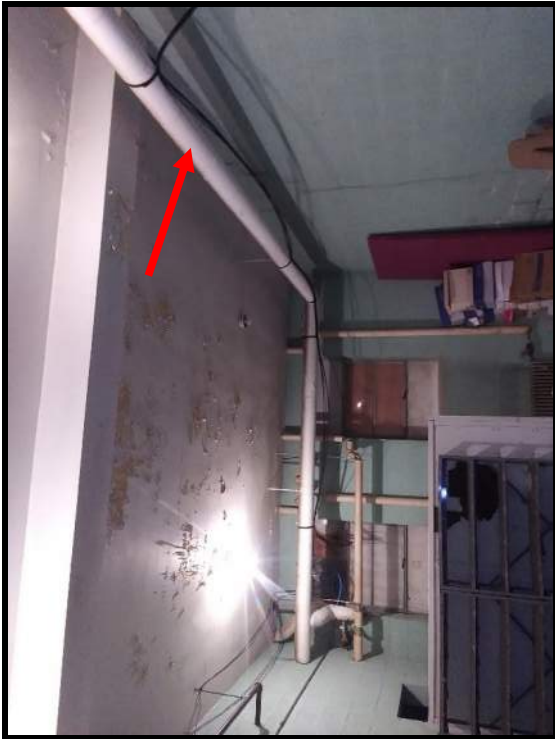
5 TSI tested positive for asbestos (15% amosite and 3% chrysotile).

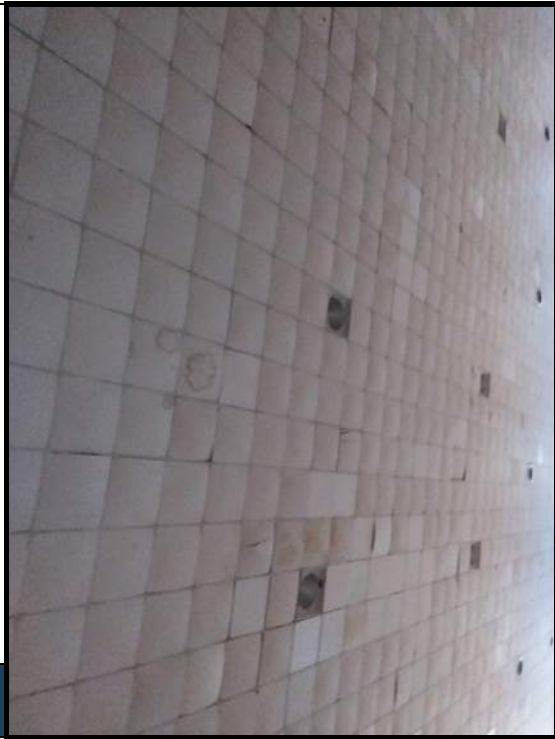
7 2x2 ceiling tile tested negative for asbestos via PLM analysis.

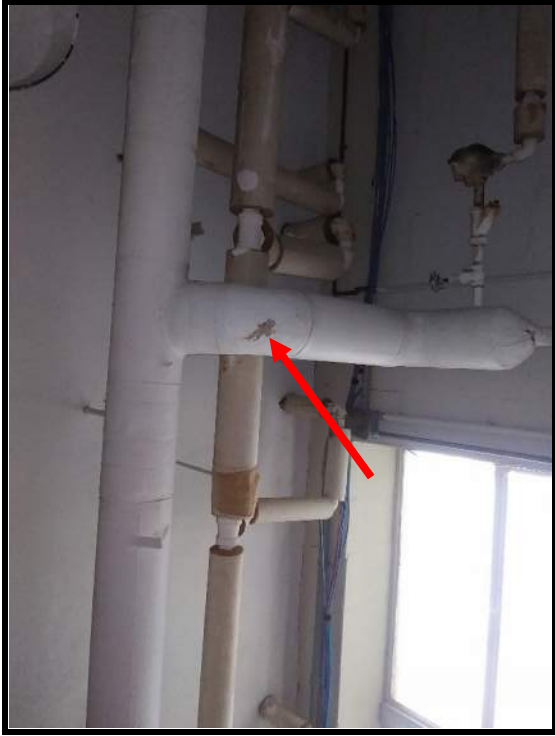
6 Hard joint tested positive for asbestos (65% chrysotile).

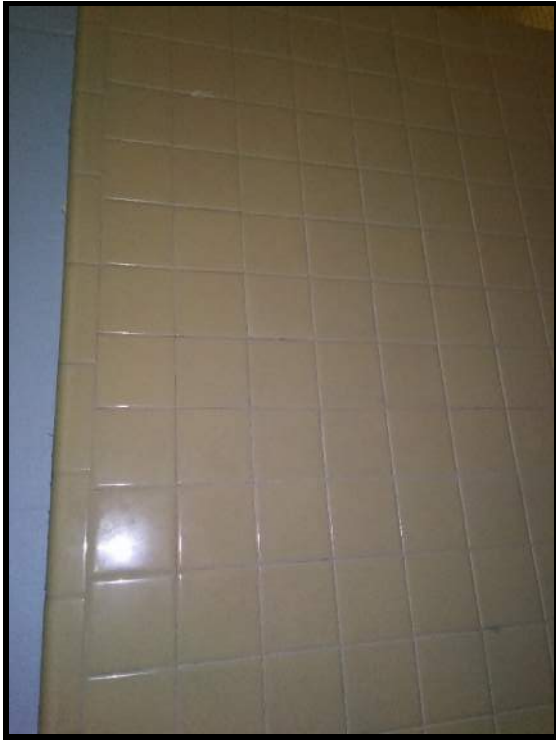
**9** Yellow ceramic tile in men's restroom tested positive for lead-based paint (7.70 mg/cm<sup>2</sup>).

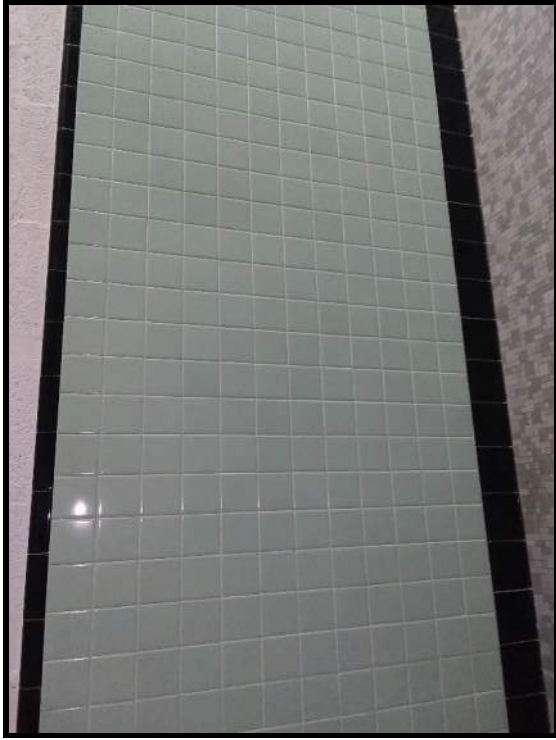
**10** Green and black ceramic tile in men's restroom tested positive for lead based paint (5.40-19.90 mg/cm<sup>2</sup>).

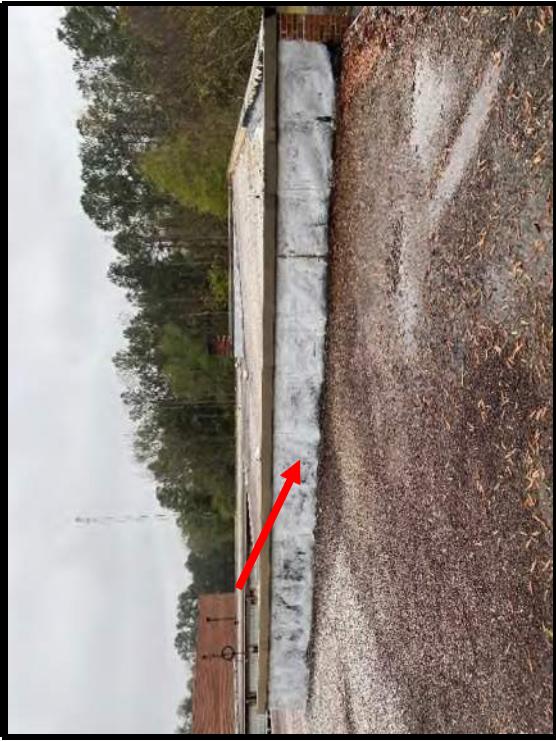
**11** Silver sealant on parapet walls tested (<1% chrysotile) PLM analysis and no asbestos detected by TEM.

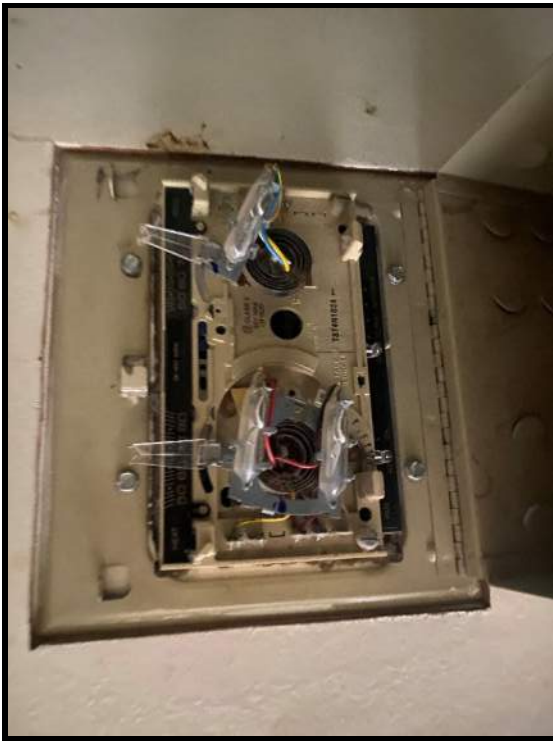
13 Mercury thermostat in the cafeteria.

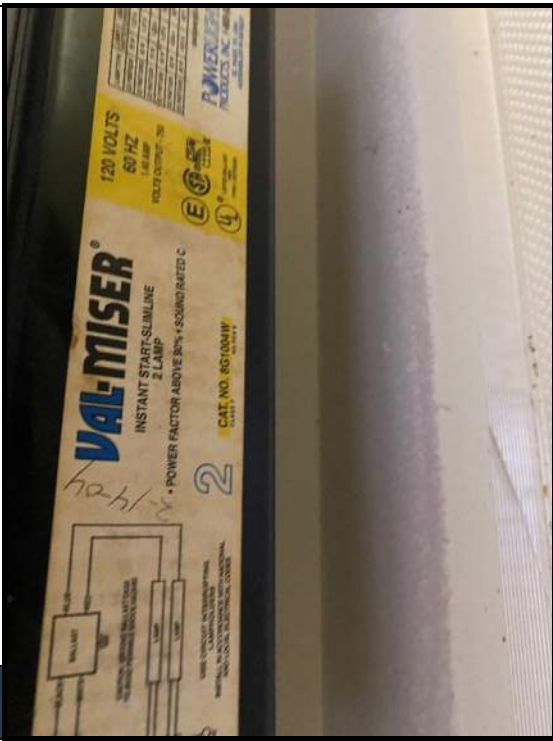
15 Ballast presumed to contain PCBs.

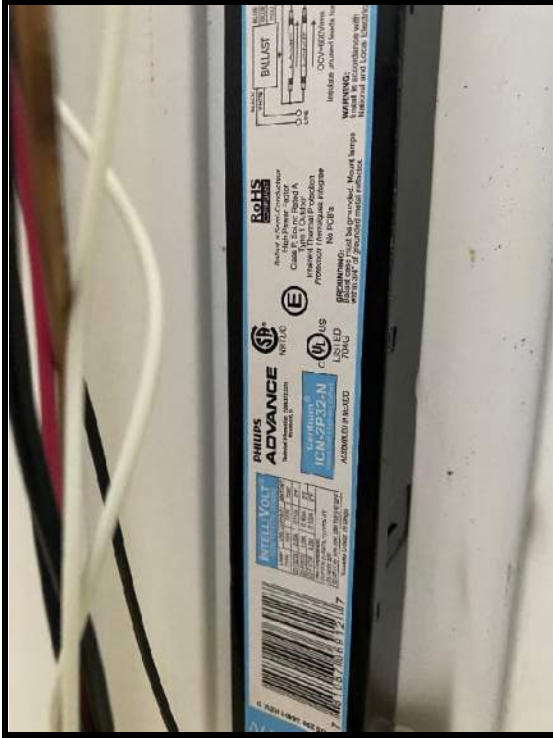
14 Ballast labeled no PCBs.

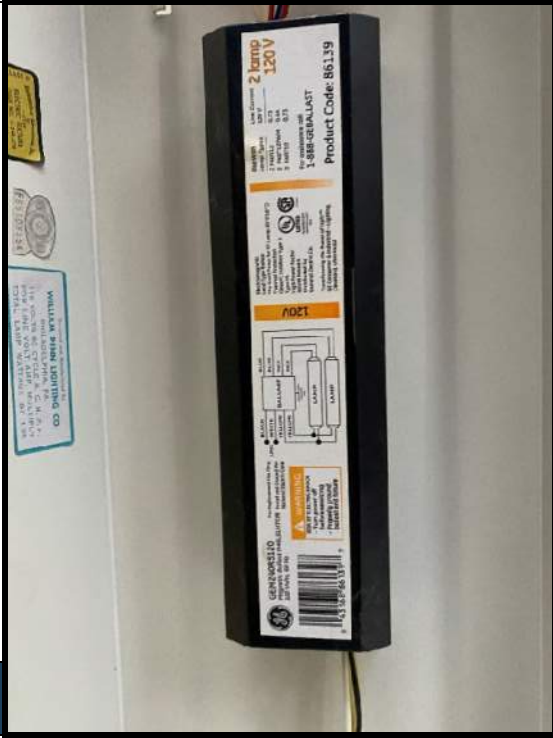
16 Electromagnetic ballast no PCBs.

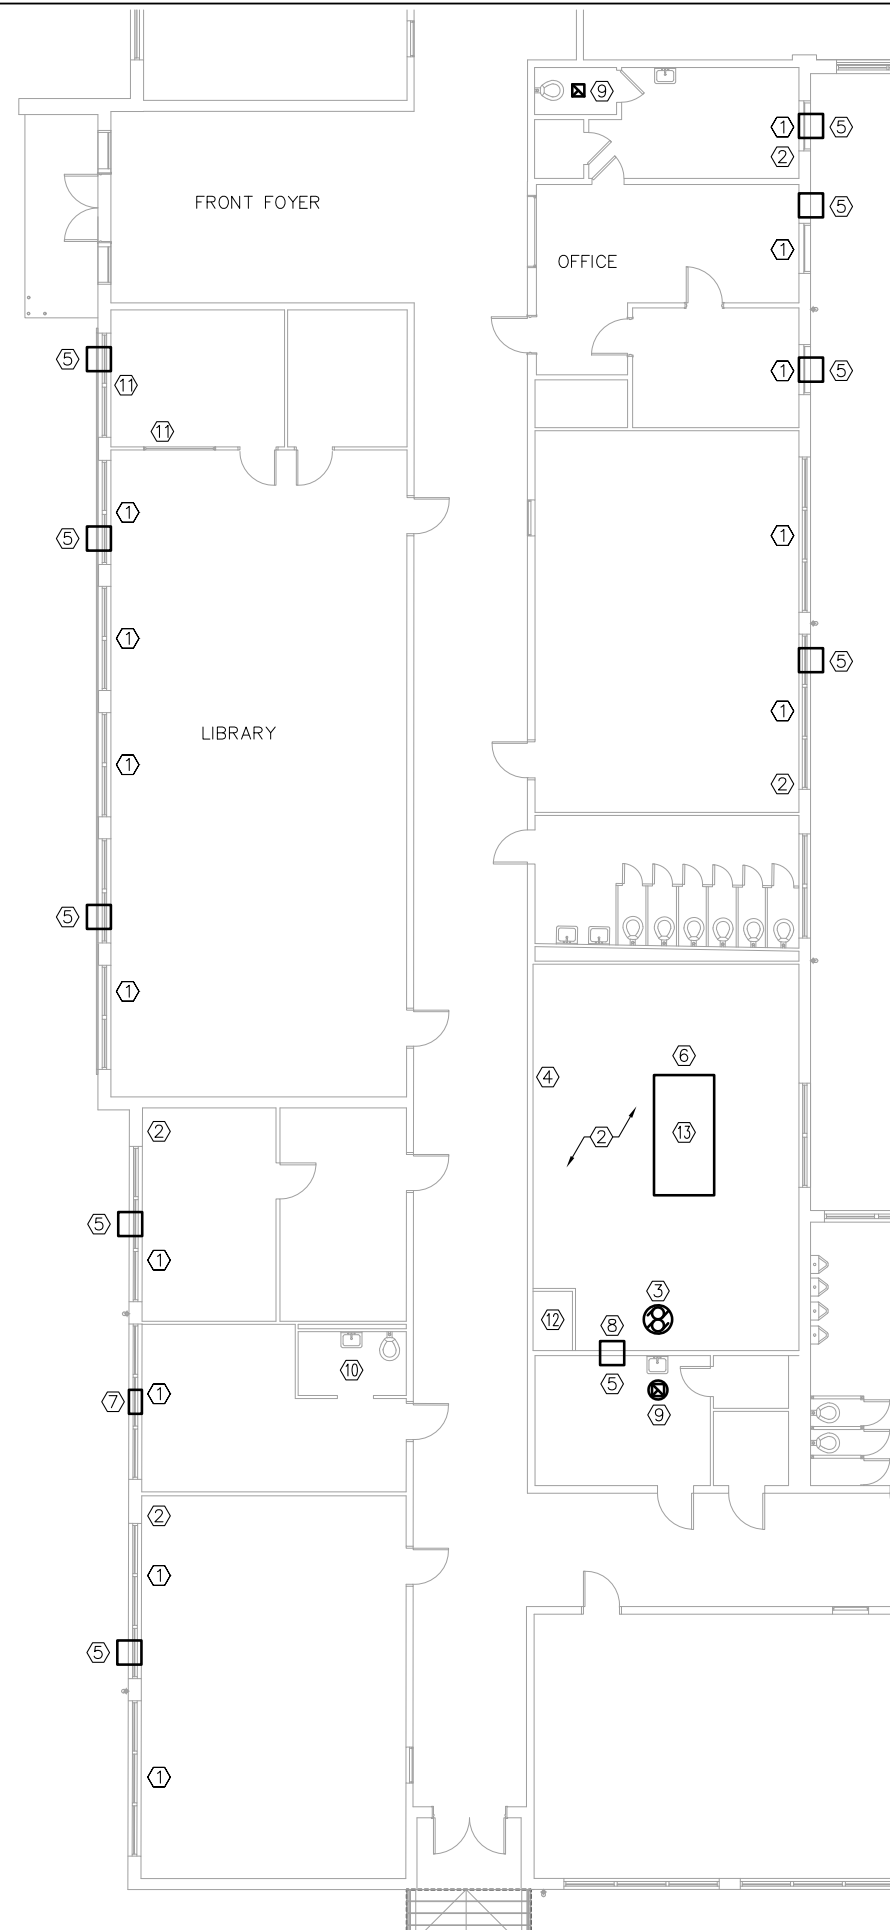
**FOYER AND SCHOOL OFFICES**  
SCALE: NTS

- KEYED NOTES (THIS SHEET ONLY)**
- ① STEAM RADIATOR.
  - ② EXPOSED PIPE INSULATION DAMAGED MISSING OR WRONG TYPE. INSULATION SHOULD BE TESTED FOR ASBESTOS.
  - ③ EXISTING STEAM CONDENSATE RETURN PUMPS.
  - ④ EXISTING BOILER CONTROLS.
  - ⑤ WINDOW AC UNIT INSTALLED.
  - ⑥ ROOF LEAKS DAMAGING PIPE INSULATION.
  - ⑦ WINDOW AC UNIT HAS BEEN REMOVED.
  - ⑧ THRU WALL AC UNIT DISCHARGES INTO ADJACENT BOILER ROOM.
  - ⑨ ROOF MOUNTED EXHAUST FAN.
  - ⑩ NO EXHAUST IN TOILET.
  - ⑪ OVERHEAD STEAM RADIATORS.
  - ⑫ RECOMMEND HAVING BRICK CHIMNEY INSPECTED IF BEING REUSED IN THE FUTURE.
  - ⑬ EXISTING HEATING STEAM BOILER, PEERLESS MODEL LCE-19-W/S, MFG: 2001, LAST INSPECTION 9/25/2015. NATURAL GAS.
  - ⑭ EXISTING STEAM CONDENSATE RETURN PUMPS.
  - ⑮ EXISTING BOILER CONTROLS.

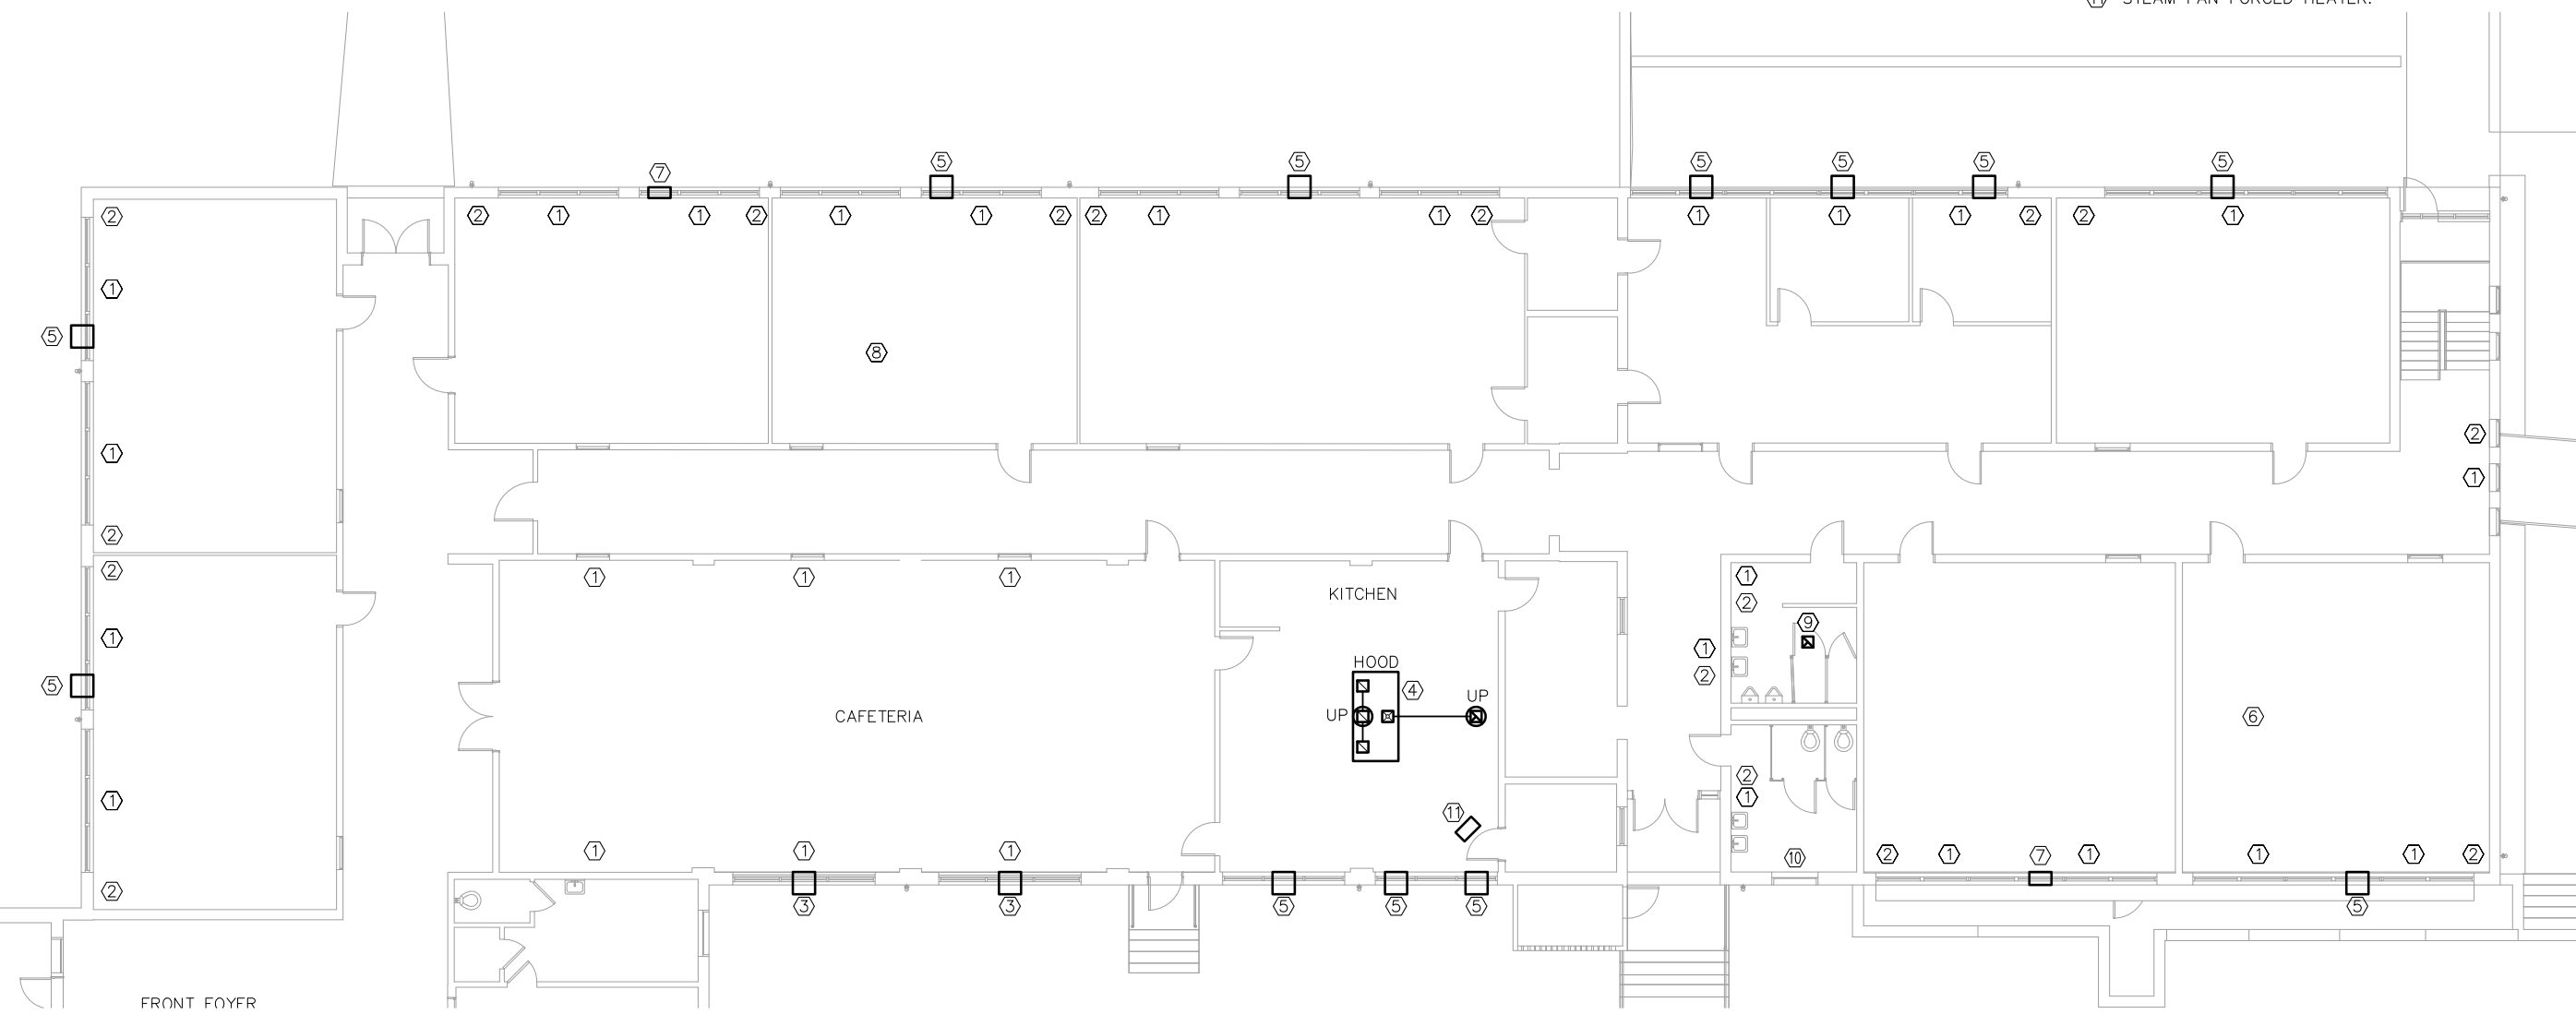
**CAFETERIA WING**  
SCALE: NTS

- ① HOT WATER RADIATOR.
- ② EXPOSED PIPE INSULATION DAMAGED MISSING OR WRONG TYPE. INSULATION SHOULD BE TESTED FOR ASBESTOS.
- ③ BARD WALL MOUNTED HEAT PUMP WITH GRILLES. MFG DATE: 1990.
- ④ KITCHEN EXHAUST HOOD, EXHAUST FAN, MAKE-UP AIR FAN AND DUCTWORK.
- ⑤ WINDOW AC UNIT INSTALLED.
- ⑥ CEILING FAN MISSING BLADES.
- ⑦ WINDOW AC UNIT HAS BEEN REMOVED.
- ⑧ ROOF MOUNTED EXHAUST FAN.
- ⑨ EXHAUST FAN NEEDS TO BE REPLACED.
- ⑩ SIDEWALL EXHAUST FAN NEEDS TO BE REPLACED.
- ⑪ STEAM FAN FORCED HEATER.

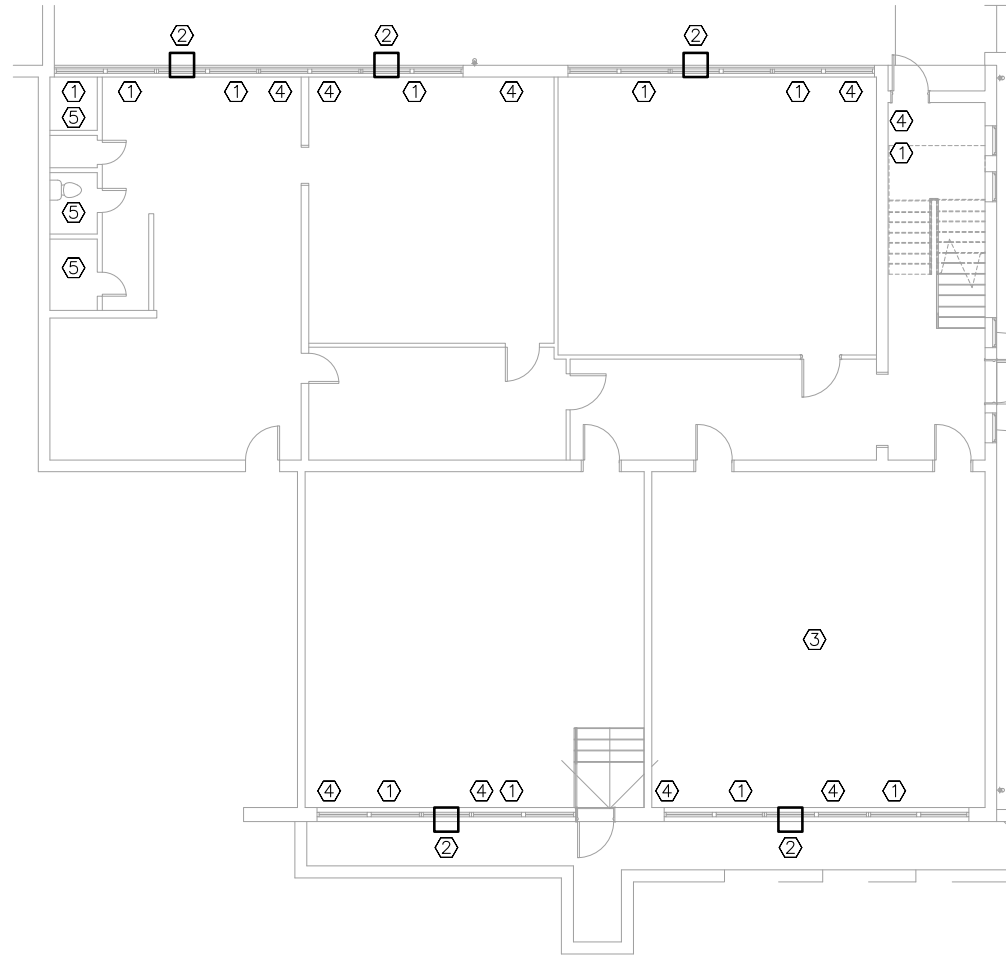
**CAFETERIA WING – LOWER ADDITION**  
SCALE: NTS

- ① EXISTING STEAM RADIATOR.
- ② WINDOW AC UNIT.
- ③ CEILING FAN MISSING BLADES.
- ④ EXPOSED PIPE INSULATION DAMAGED MISSING OR WRONG TYPE. INSULATION SHOULD BE TESTED FOR ASBESTOS.
- ⑤ WALL MOUNTED FAN IN TOILET NEEDS TO BE REPLACED AND DUCTED TO EXTERIOR OF BUILDING.

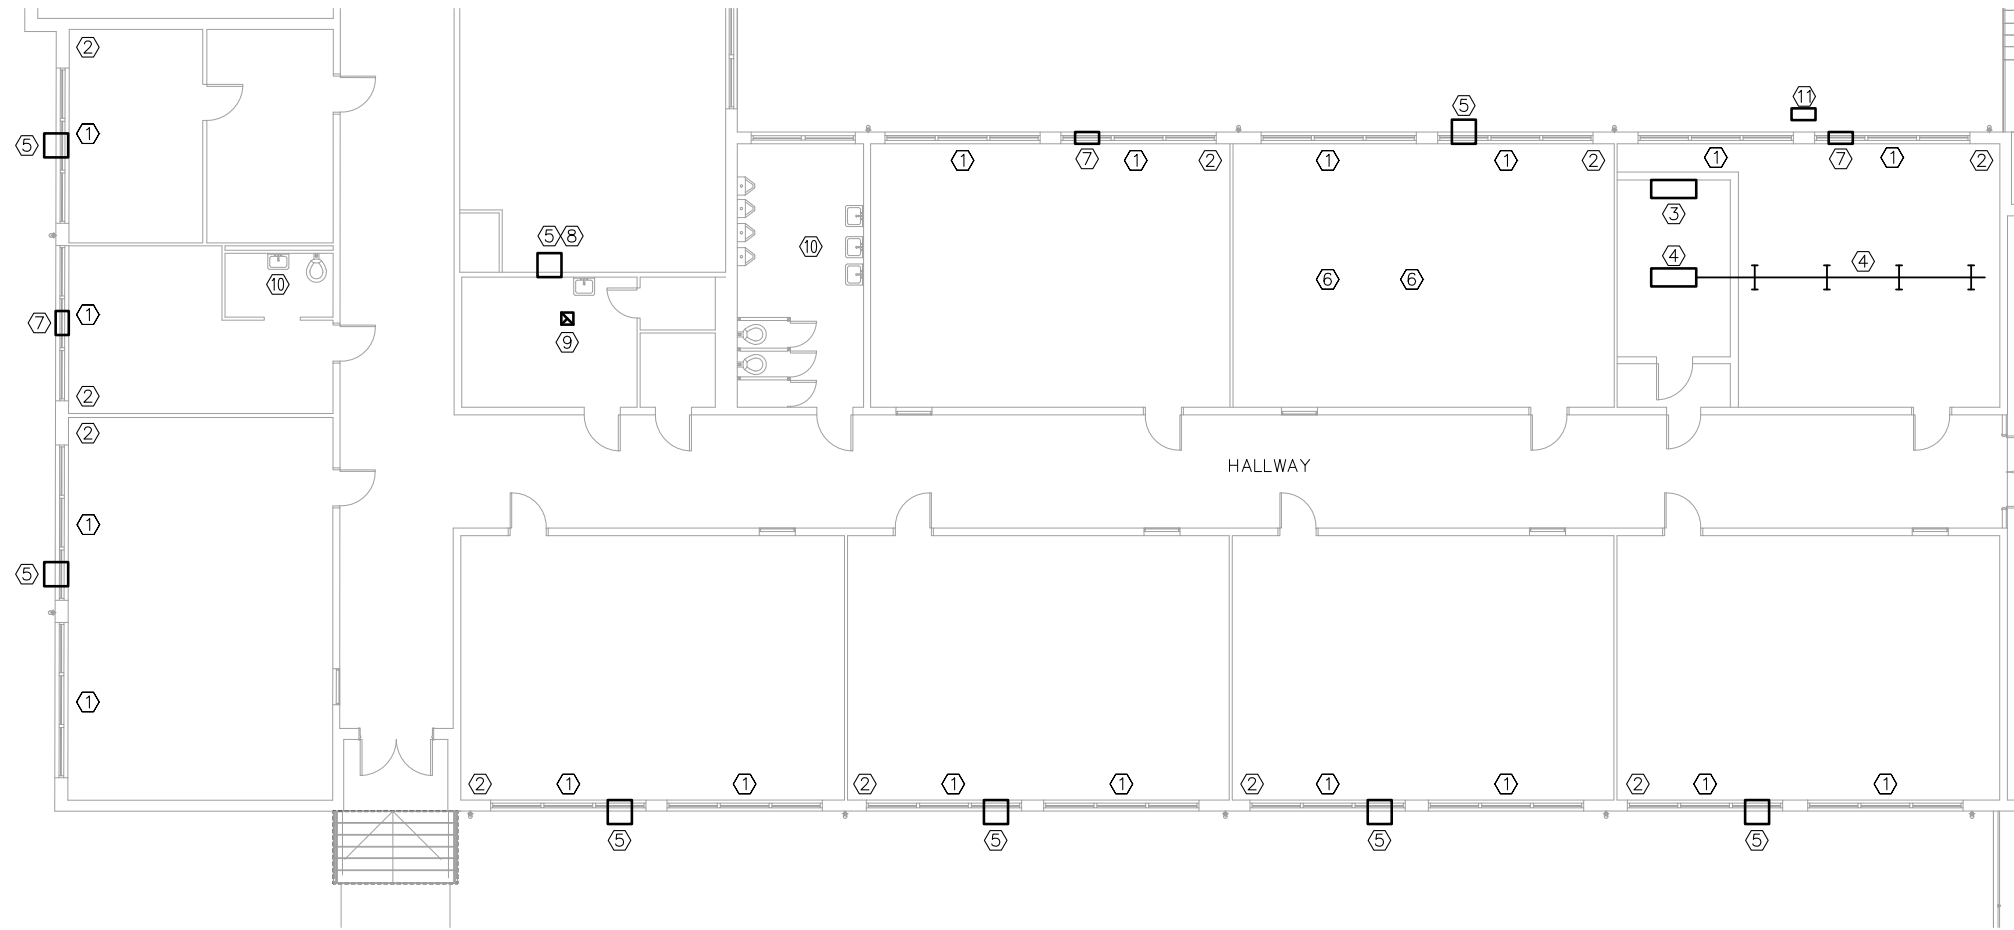
**CLASSROOM WING**  
SCALE: NTS

- ① STEAM RADIATOR.
- ② EXPOSED PIPE INSULATION DAMAGED MISSING OR WRONG TYPE. INSULATION SHOULD BE TESTED FOR ASBESTOS.
- ③ WALL MOUNT DUCTLESS AIR HANDLER (3/4 TON).
- ④ DUCTWORK INSTALLED, NO AIR HANDLER OR CONDENSING UNIT.
- ⑤ WINDOW AC UNIT INSTALLED.
- ⑥ CEILING FAN MISSING BLADES.
- ⑦ WINDOW AC UNIT HAS BEEN REMOVED.
- ⑧ THRU WALL AC UNIT DISCHARGES INTO ADJACENT BOILER ROOM.
- ⑨ ROOF MOUNTED EXHAUST FAN.
- ⑩ NO EXHAUST IN TOILET.
- ⑪ MINI SPLIT HEAT PUMP ON WALL BRACKETS (3/4 TON).

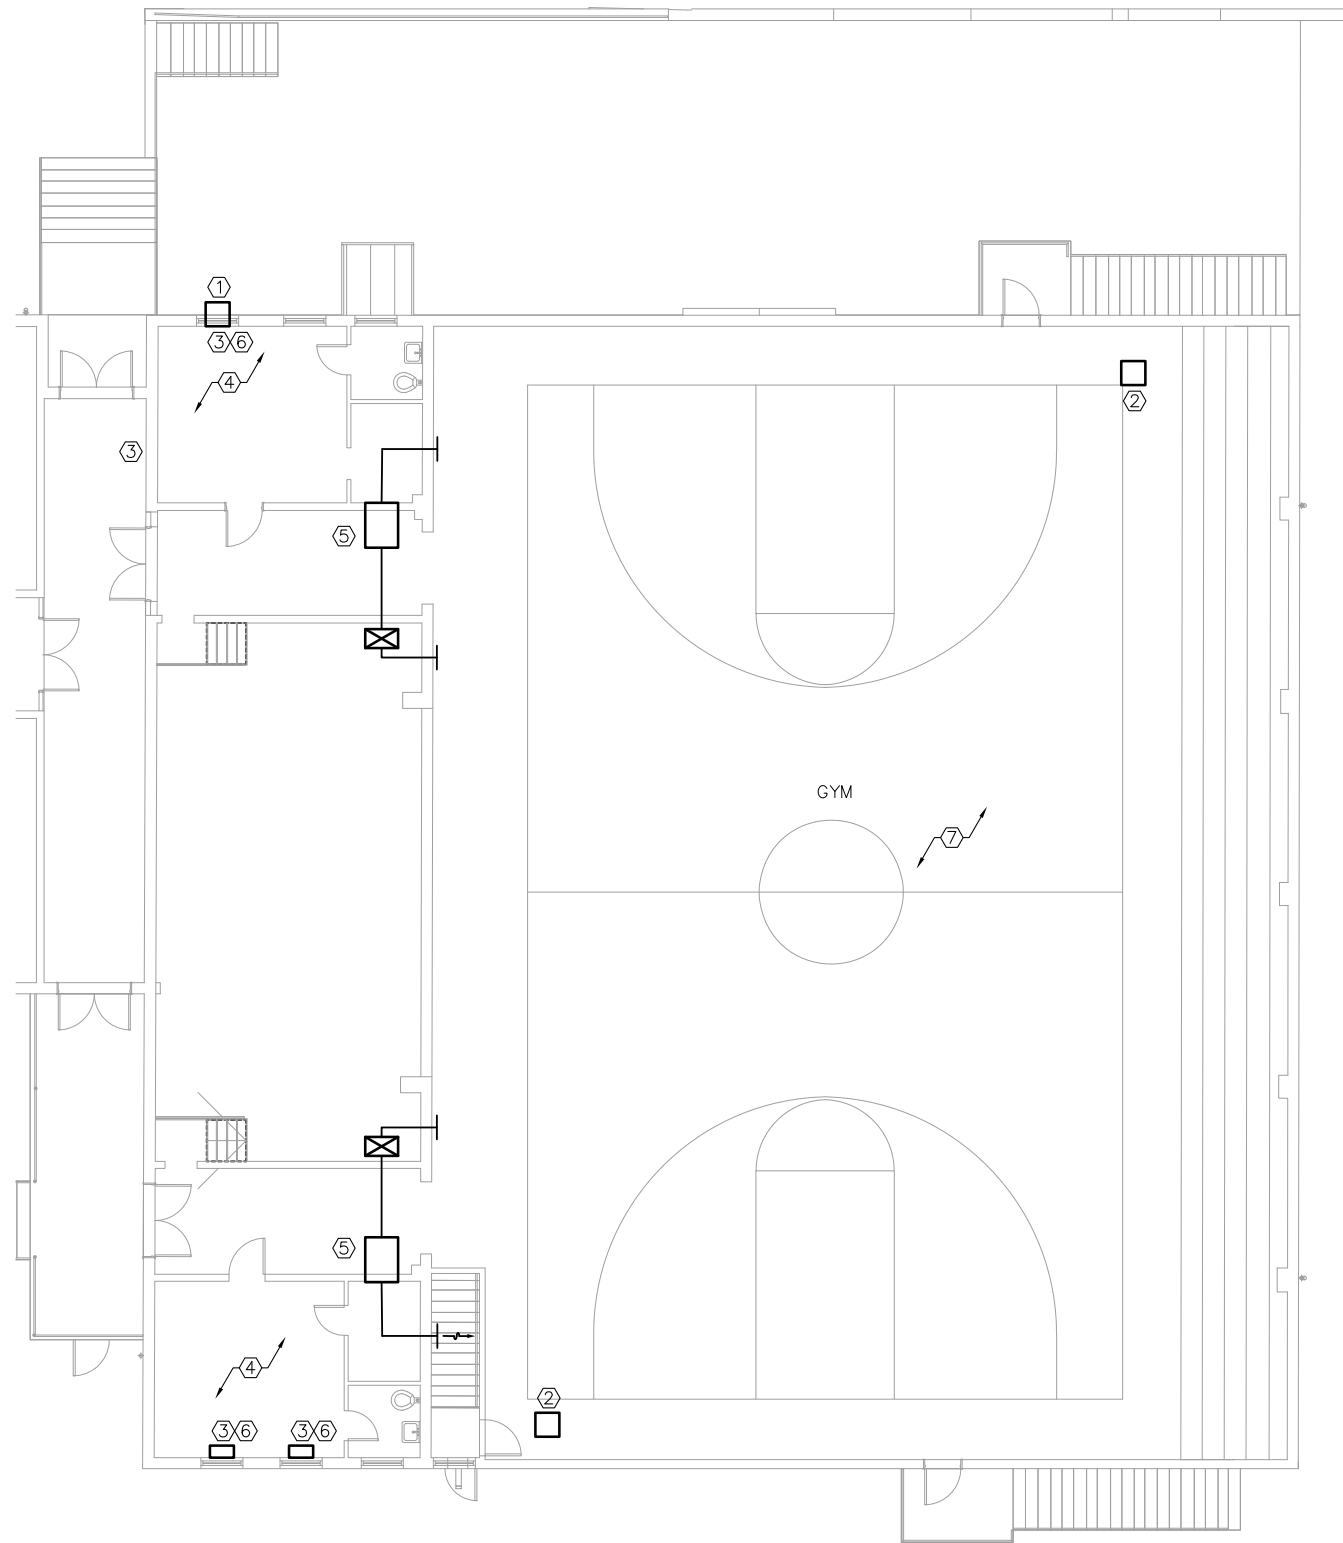
**GYM - UPPER LEVEL**  
SCALE: NTS

- ① WINDOW UNIT INSTALLED
- ② GAS HEATER MOUNTED HIGH ON WALL
- ③ FLOOR MOUNTED STEAM RADIATOR
- ④ EXPOSED PIPE INSULATION DAMAGED, MISSING OR WRONG TYPE. INSULATION SHOULD BE TESTED FOR ASBESTOS.
- ⑤ STEAM FAN COIL WITH DUCTWORK. (NO COOLING)
- ⑥ STEAM RADIATOR MISSING COVER HOUSING.
- ⑦ GYM IS PRESENTLY HEATED BUT NOT COOLED. RECOMMEND HAVING A THERMAL LOAD ANALYSIS DONE.

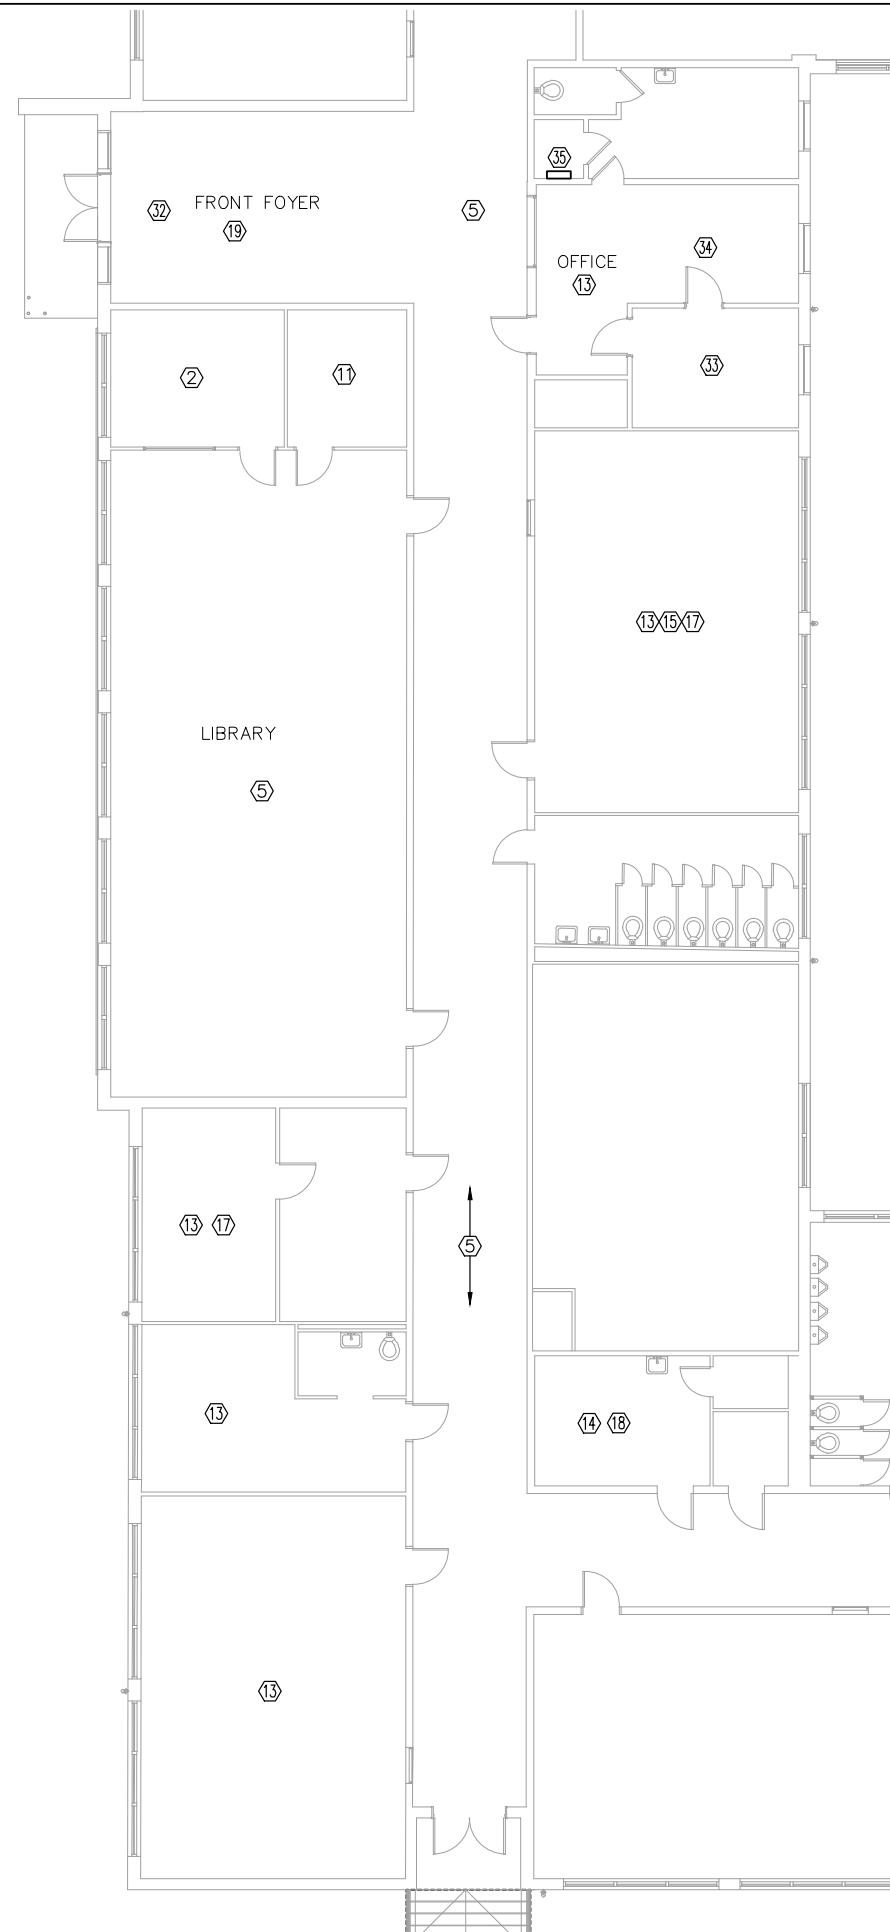
**FOYER AND SCHOOL OFFICES**  
SCALE: NTS

- KEYED NOTES (THIS SHEET ONLY)**
- ① OLD INCANDESCENT RETROFIT WITH COMPACT FLUORESCENTS AND THEN 1 X 4 TWO LAMP T-12
  - ② 2X4 T-BAR
  - ③ 2X4 SURFACE
  - ④ 12X12 RECESSED

- ⑤ 1X8 T-12
  - ⑥ CONDUIT NOT PROPERLY SUPPORTED
  - ⑦ TRIP HAZARD CLEAN OUT
  - ⑧ KILN CIRCUIT IS NOT TERMINATED PROPERLY
  - ⑨ INCANDESCENTS WITHOUT LENSES

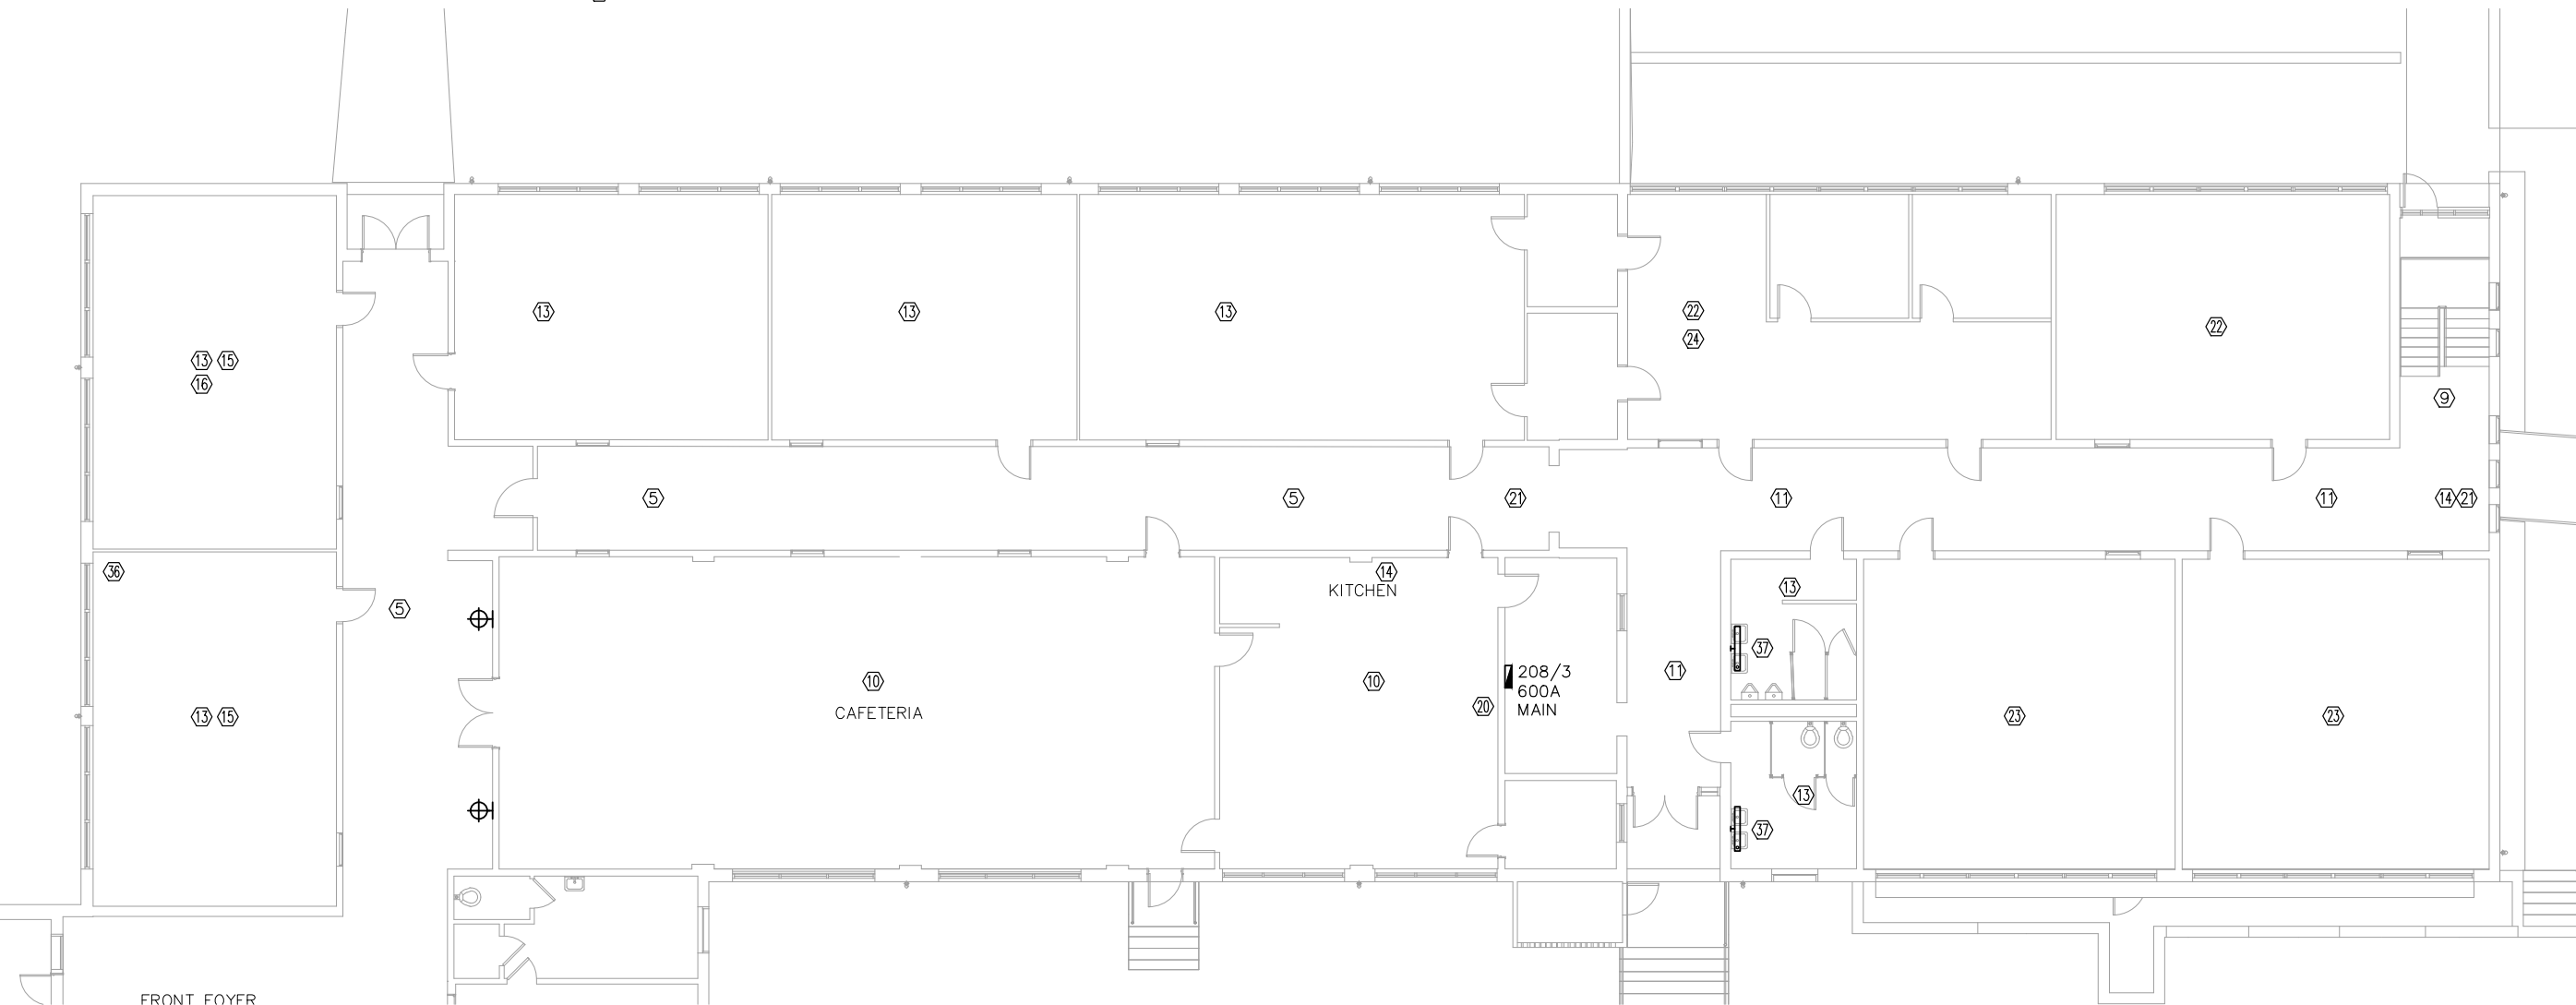
**CAFETERIA WING**  
SCALE: NTS

- ㉕ RUSTED SPECIAL PURPOSE RECEPTACLE
- ㉖ NON WET RATED FIXTURE USED IN SHOWER ROOMS.
- ㉗ MAIN ELECTRICAL AND SUB PANELS – MANUFACTURED BY FEDERAL ELECTRIC
- ㉘ ELECTRICAL CIRCUIT IS NOT TERMINATED PROPERLY.
- ㉙ 12 SPACE ELECTRICAL PANEL.
- ㉚ 200A, PANEL B2.
- ㉛ 4 SPACE PANEL.
- ㉜ NO REMOTE ANNUNCIATOR.
- ㉝ TWO LAMP X 8’ PENDANT.
- ㉞ TWO LAMP X 16’ PENDANT.
- ㉟ TELEPHONE BACKERBOARD.
- ㊱ CABLE BOX DETACHED FROM WALL
