## **SPECIFICATIONS FOR ASBESTOS ABATEMENT**

**OLD GALLMAN SCHOOL  
540 BRANTLEY STREET  
NEWBERRY, SC**

**CRE Project #: PD24-1120-24513**

Hazardous Materials Assessment Report  
Gallman School  
540 Brantley Street  
Newberry, South Carolina  
S&ME Project No. 22610550R.1

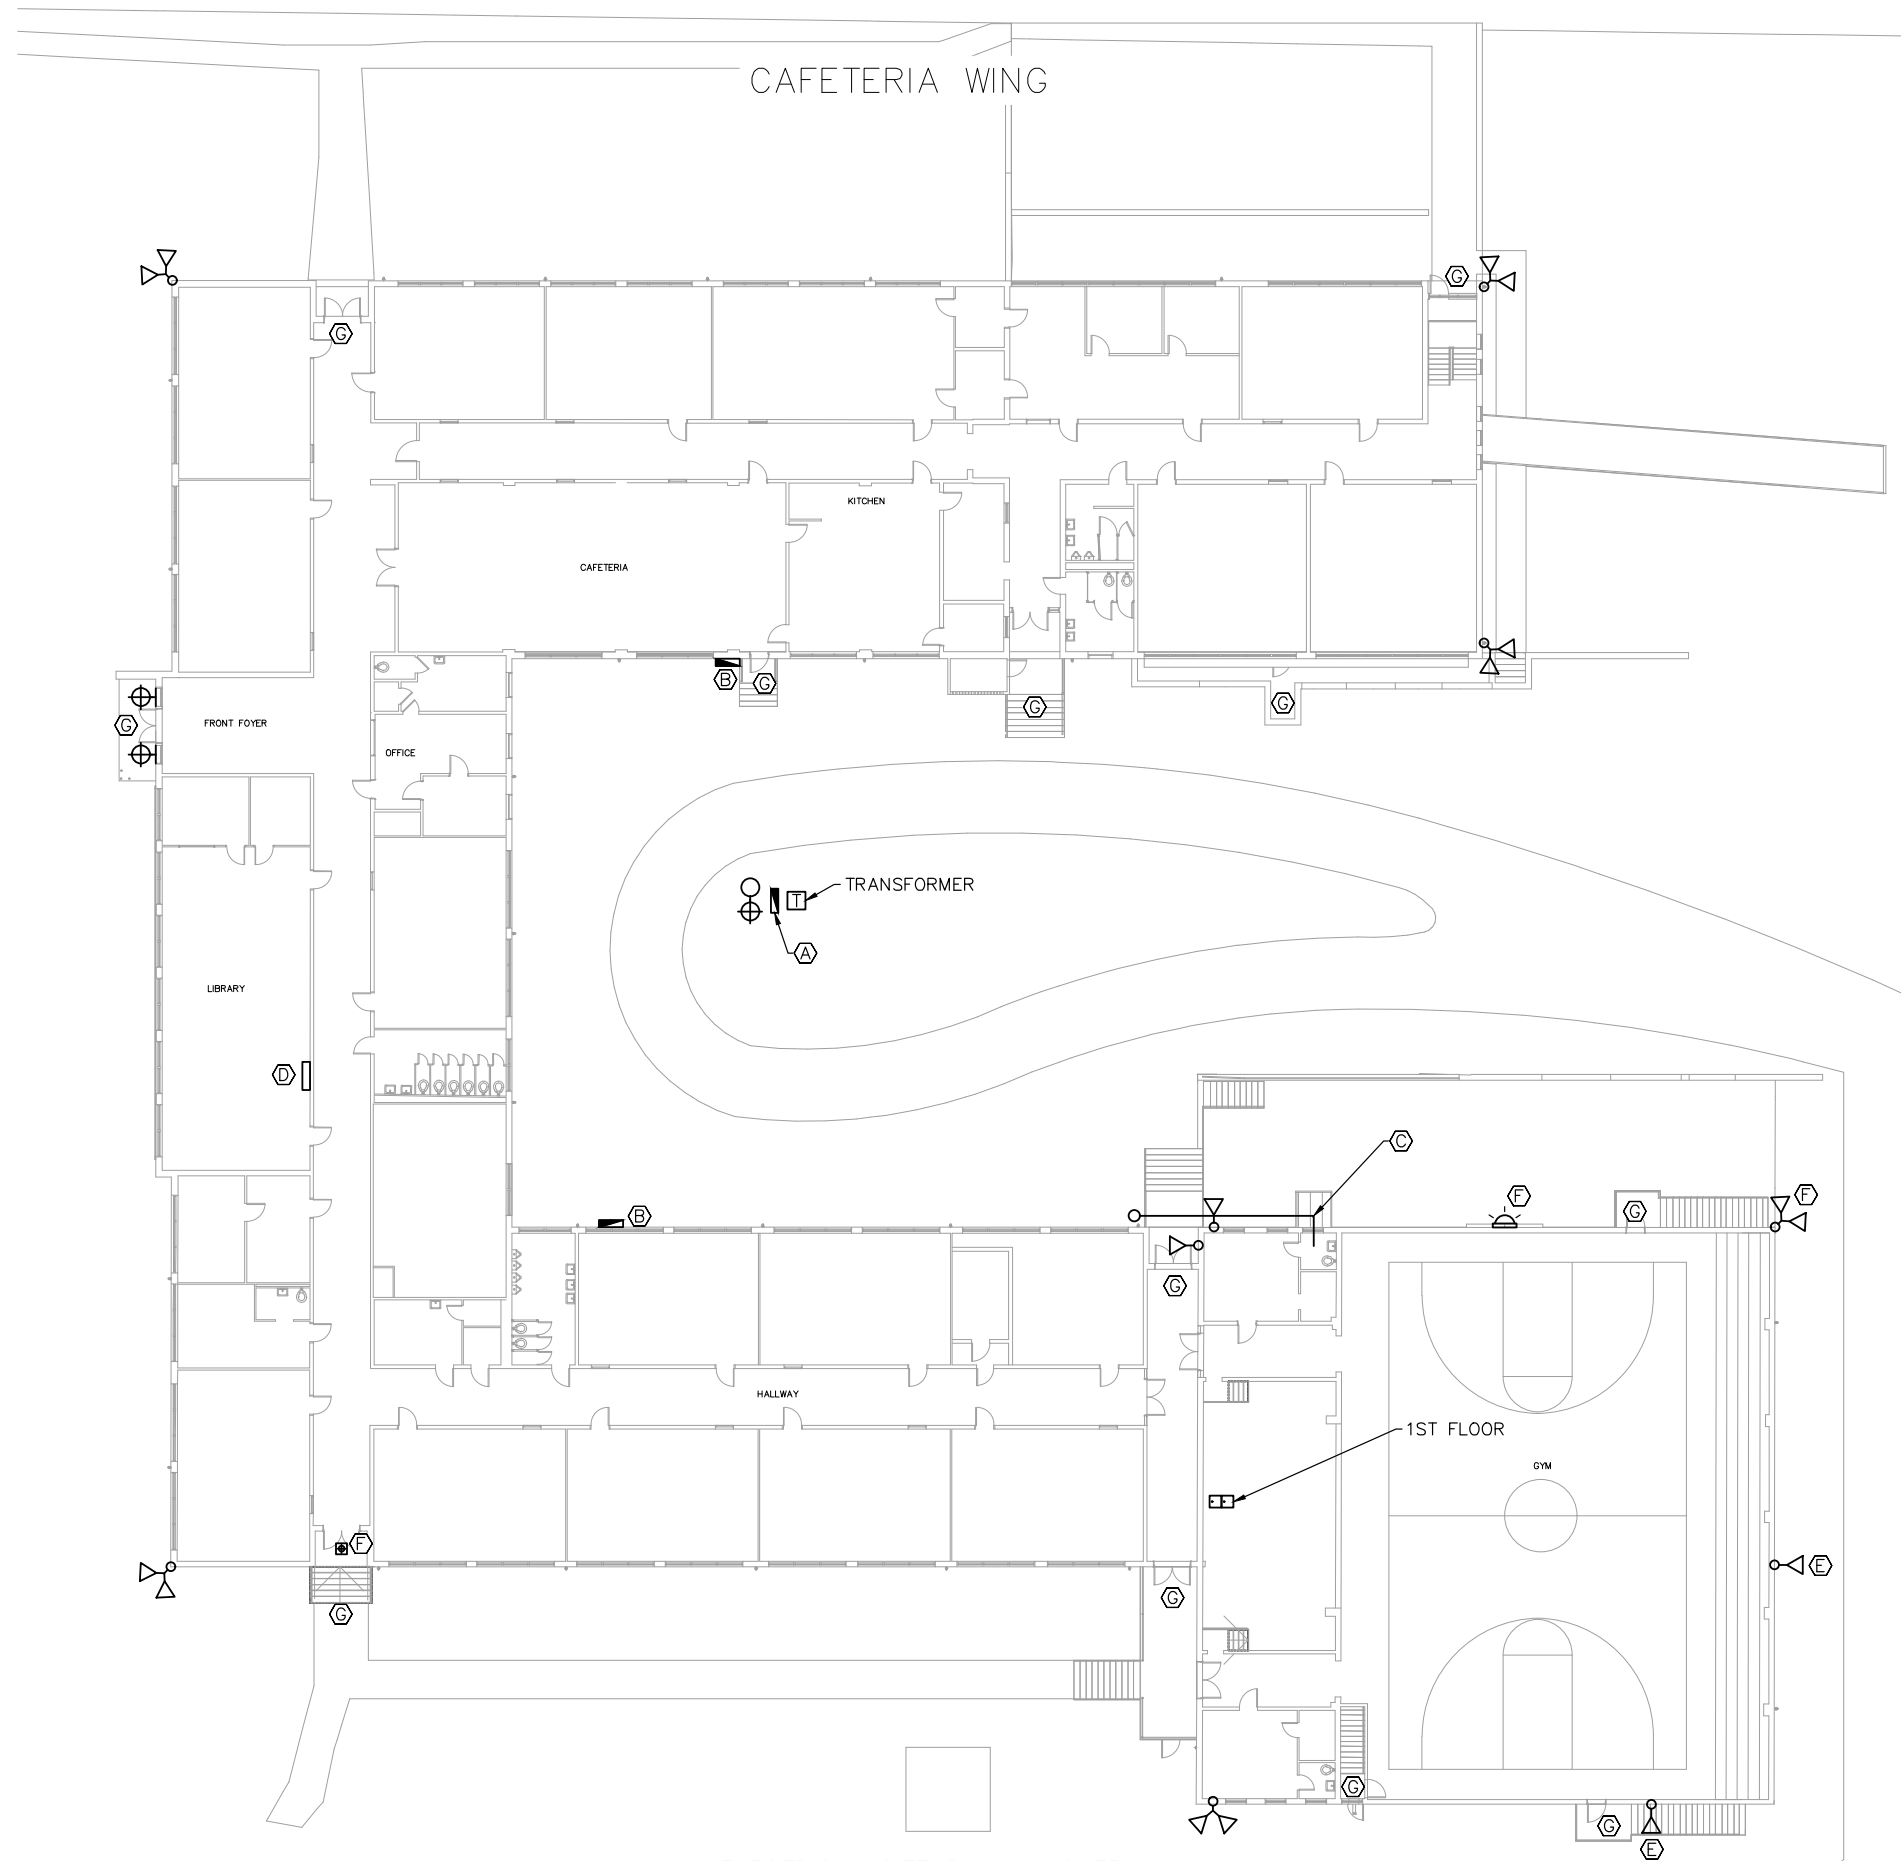
**ELECTRICAL SITE PLAN – OVERALL**  
SCALE: NTS

- KEYED NOTES (THIS SHEET ONLY)**
- (A) EXTERIOR DISTRIBUTION PANEL.
  - (B) 225AMP HVAC PANEL.
  - (C) CIRCUIT INSTALLED IN AN UNCONVENTIONAL MANNER.
  - (D) BOILER CONTROLS LOCATED IN BASEMENT.
  - (E) LIGHT FIXTURE HAS BEEN REMOVED AND THE JUNCTION BOX HAS BEEN FILLED WITH CONCRETE.
  - (F) DAMAGED LIGHT FIXTURE.
  - (G) NO EMERGENCY EGRESS LIGHTING.

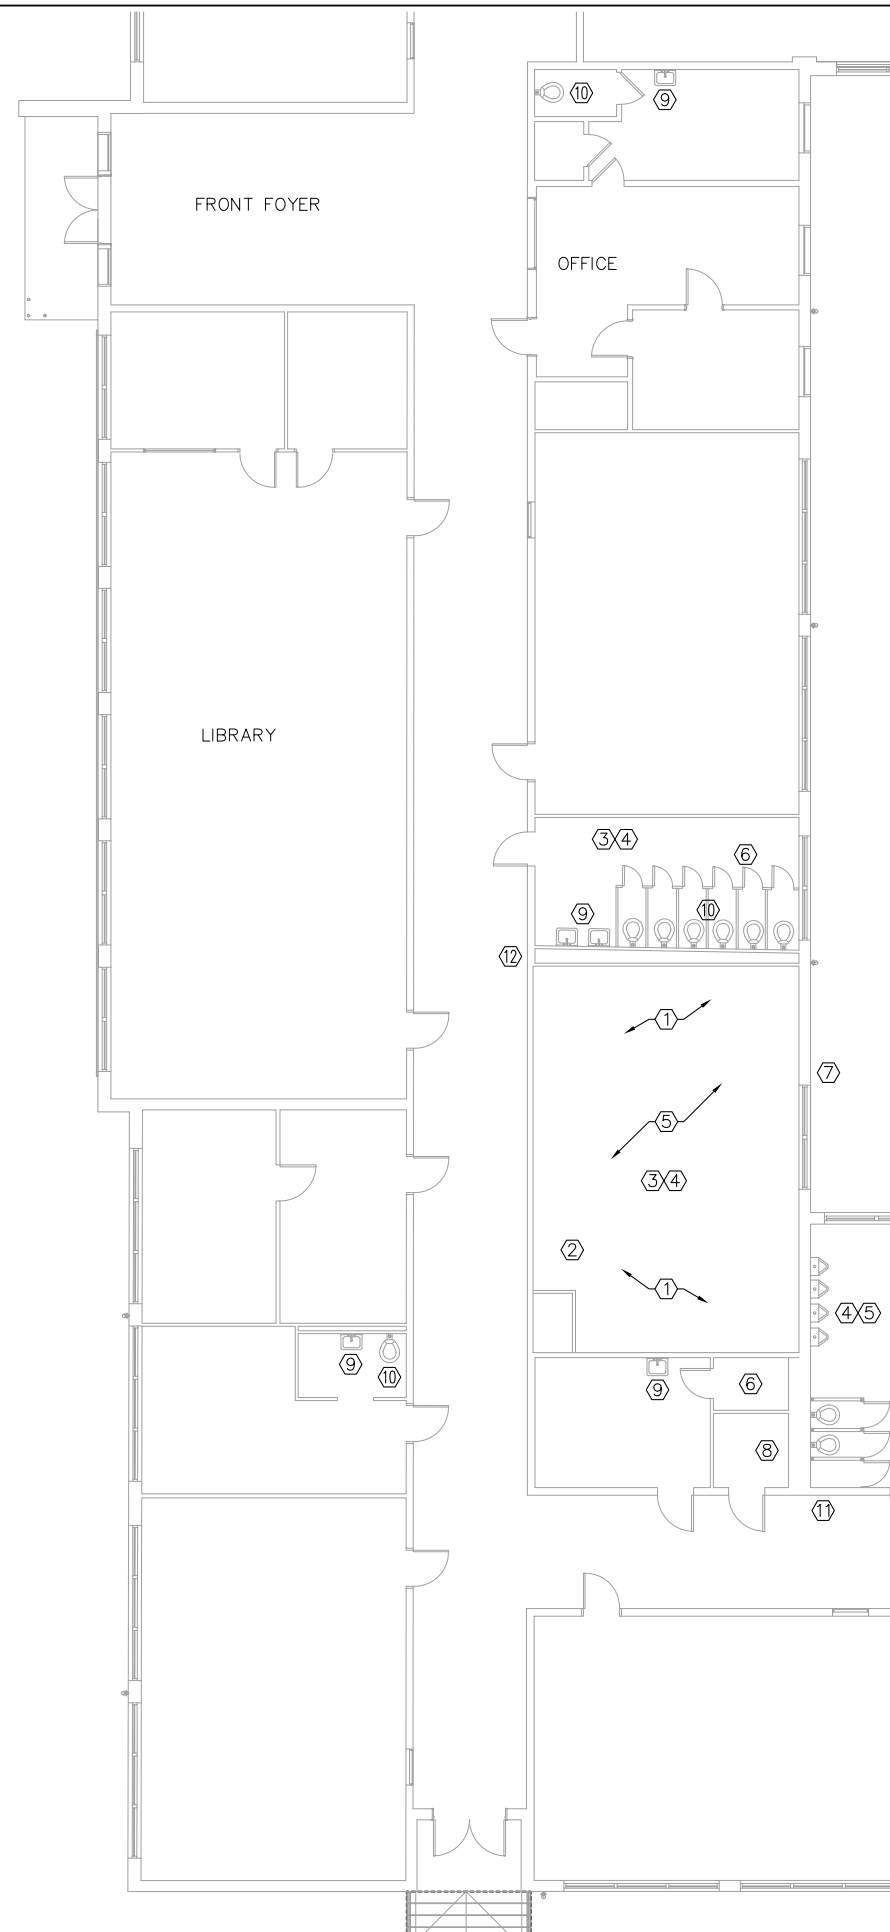
**FOYER AND SCHOOL OFFICES**  
SCALE: NTS

- KEYED NOTES (THIS SHEET ONLY)**
- ① FLOOR DRAINS ARE CLOGGED AND NEED TO BE CLEANED.
  - ② 40 GALLON NATURAL GAS WATER HEATER, BY CRAFTMASTER, MFG DATE: 2007. NO DRAIN PAN, EXPANSION TANK, VACUUM BREAKER.
  - ③ MOST OF THE WASTE PIPING FOR THIS AREA IS CAST IRON THOUGH SOME PVC HAS BEEN USED.
  - ④ MOST OF THE DOMESTIC WATER PIPING IN THIS AREA IS COPPER. HOT WATER SYSTEM DOES NOT APPEAR TO BE RECIRCULATED.
  - ⑤ PIPE INSULATION INSTALLED IS IN NEED OF REPLACEMENT OR REPAIR.
  - ⑥ STANDING WATER IN CRAWL SPACE.
  - ⑦ GAS METER FOR BOILER ROOM.
  - ⑧ MOP SINK/FAUCET.
  - ⑨ WALL MOUNTED LAVATORY.
  - ⑩ FLOOR MOUNTED FLUSH VALVE TOILET.
  - ⑪ WALL MOUNTED DRINKING FOUNTAIN. (NON ADA)
  - ⑫ WALL MOUNTED DRINKING FOUNTAIN.

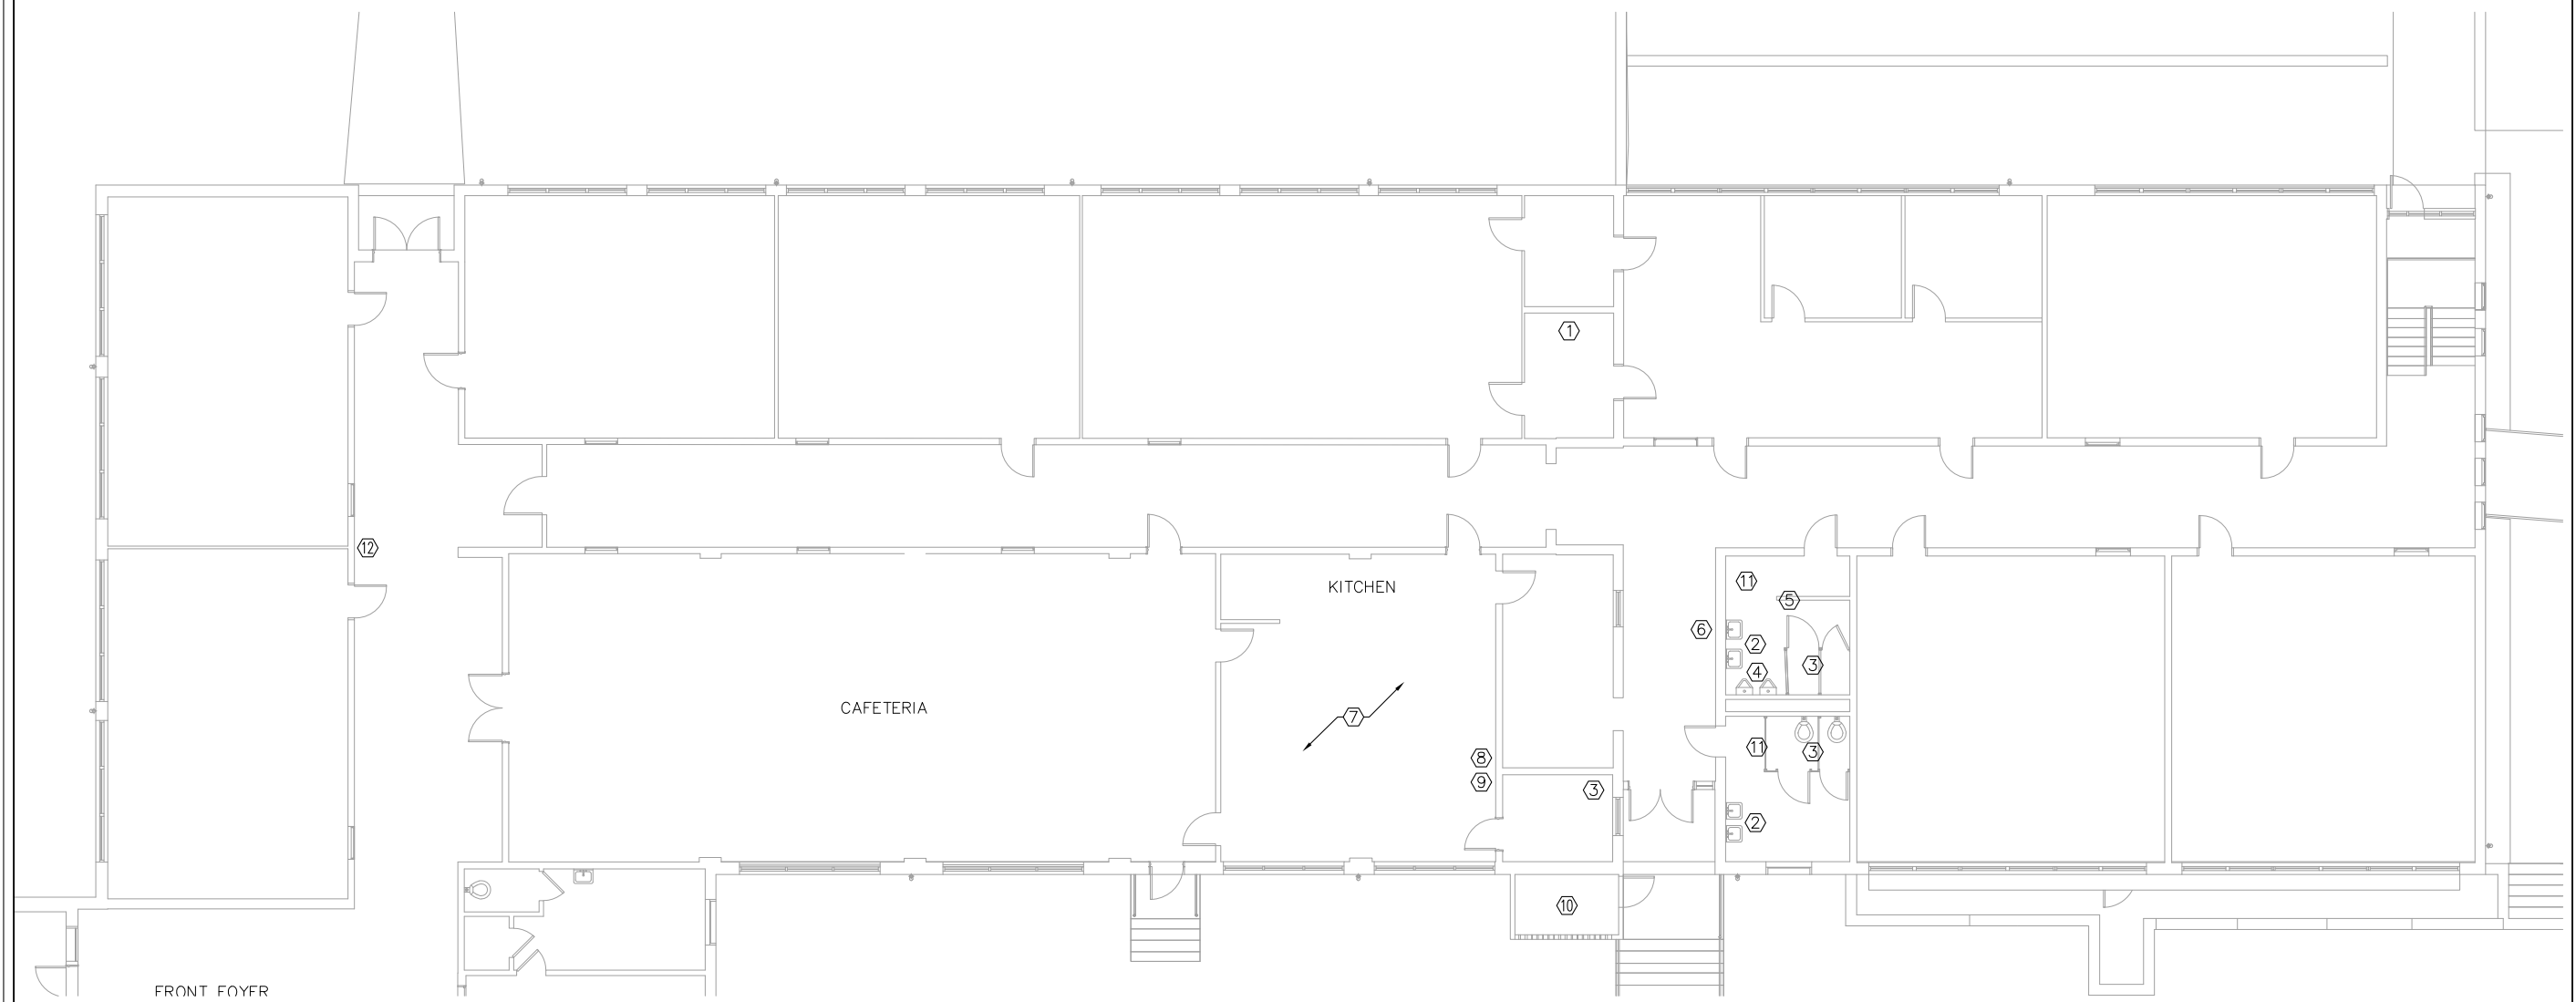
**CAFETERIA WING**  
SCALE: NTS

- ① COUNTERTOP SINK
- ② WALL MOUNTED LAVATORIES.
- ③ FLOOR MOUNTED FLUSH VALVE TOILETS
- ④ WALL MOUNTED FLUSH VALVE URINALS.
- ⑤ FLOOR DRAIN RISES ABOVE TILE FLOOR – TRIP HAZARD.
- ⑥ FLOOR STANDING, DRINKING FOUNTAIN, (NON ADA)
- ⑦ KITCHEN EQUIPMENT NO LONGER INSTALLED. PLUMBING WASTE, HOT AND COLD WATER TAPS IN VARIOUS LOCATIONS.
- ⑧ THREE COMPARTMENT SINK.
- ⑨ MOP SINK.
- ⑩ OUTSIDE CAN WASH
- ⑪ CAST IRON WASTE PIPING BELOW IN BAD CONDITION. PIPE HAS RUSTED THROUGH AND WASTE WILL DISCHARGE INTO CRAWL SPACE.
- ⑫ DRINKING FOUNTAIN LOCATION, FIXTURE REMOVED.

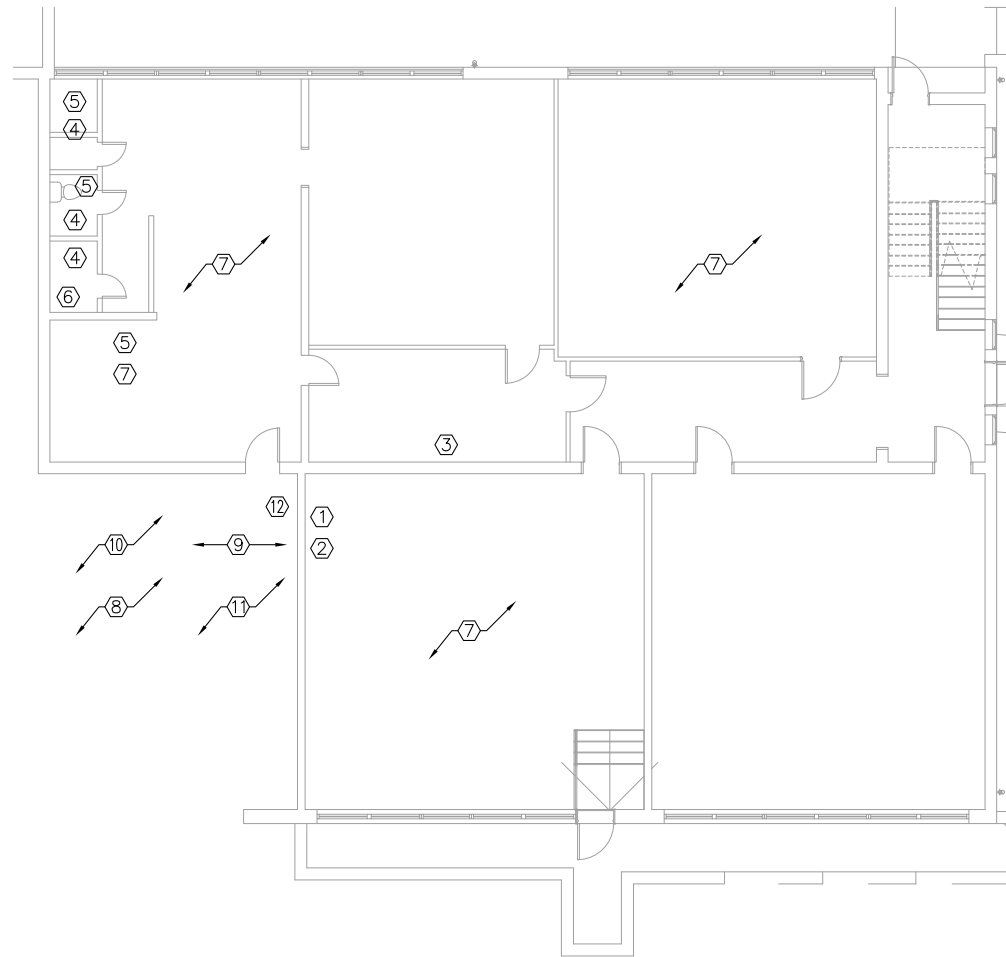
**CAFETERIA WING – LOWER ADDITION**  
SCALE: NT

- KEYED NOTES (THIS SHEET ONLY)**
- ① COUNTER TOP SINK WITH PEX PIPING AND PVC WASTE PIPING.
  - ② UNDER COUNTER WATER HEATER.
  - ③ FLOOR STANDING WATER COOLER. (NON-ADA)
  - ④ WALL MOUNTED LAVATORY.
  - ⑤ FLOOR MOUNTED FLUSH TANK TOILET.
  - ⑥ TOILET REMOVED, NEW WASTE PIPE THRU WALL TO TRANSITION AT TOILET FLOOR FLANGE.
  - ⑦ EXPOSED WASTE PIPING FOR FLOOR ABOVE IS ALL CAST IRON.
  - ⑧ CAST IRON WASTE PIPING WITH NEWER PVC TIE INS.
  - ⑨ PVC WASTE PIPING NEEDS TO BE REPLACED AND SLOPED PROPERLY. TIES INTO TOILET FLANGE. SEE NOTE 6.
  - ⑩ WATER PIPING IN CRAWL SPACE, NOT INSULATED.
  - ⑪ CAST IRON WASTE PIPING TO GANG TOILETS ABOVE IN NEED OF REPLACEMENT DUE TO RUSTING. METAL FLOOR PAN ALSO RUSTING. NOTE: SOME WASTE PIPING IS COMPLETELY RUSTED THROUGH, DRAINING INTO CRAWL SPACE.
  - ⑫ SUMP PUMP COVERED IN MUD. NEEDS TO BE REPLACED AND INSTALLED CORRECTLY.

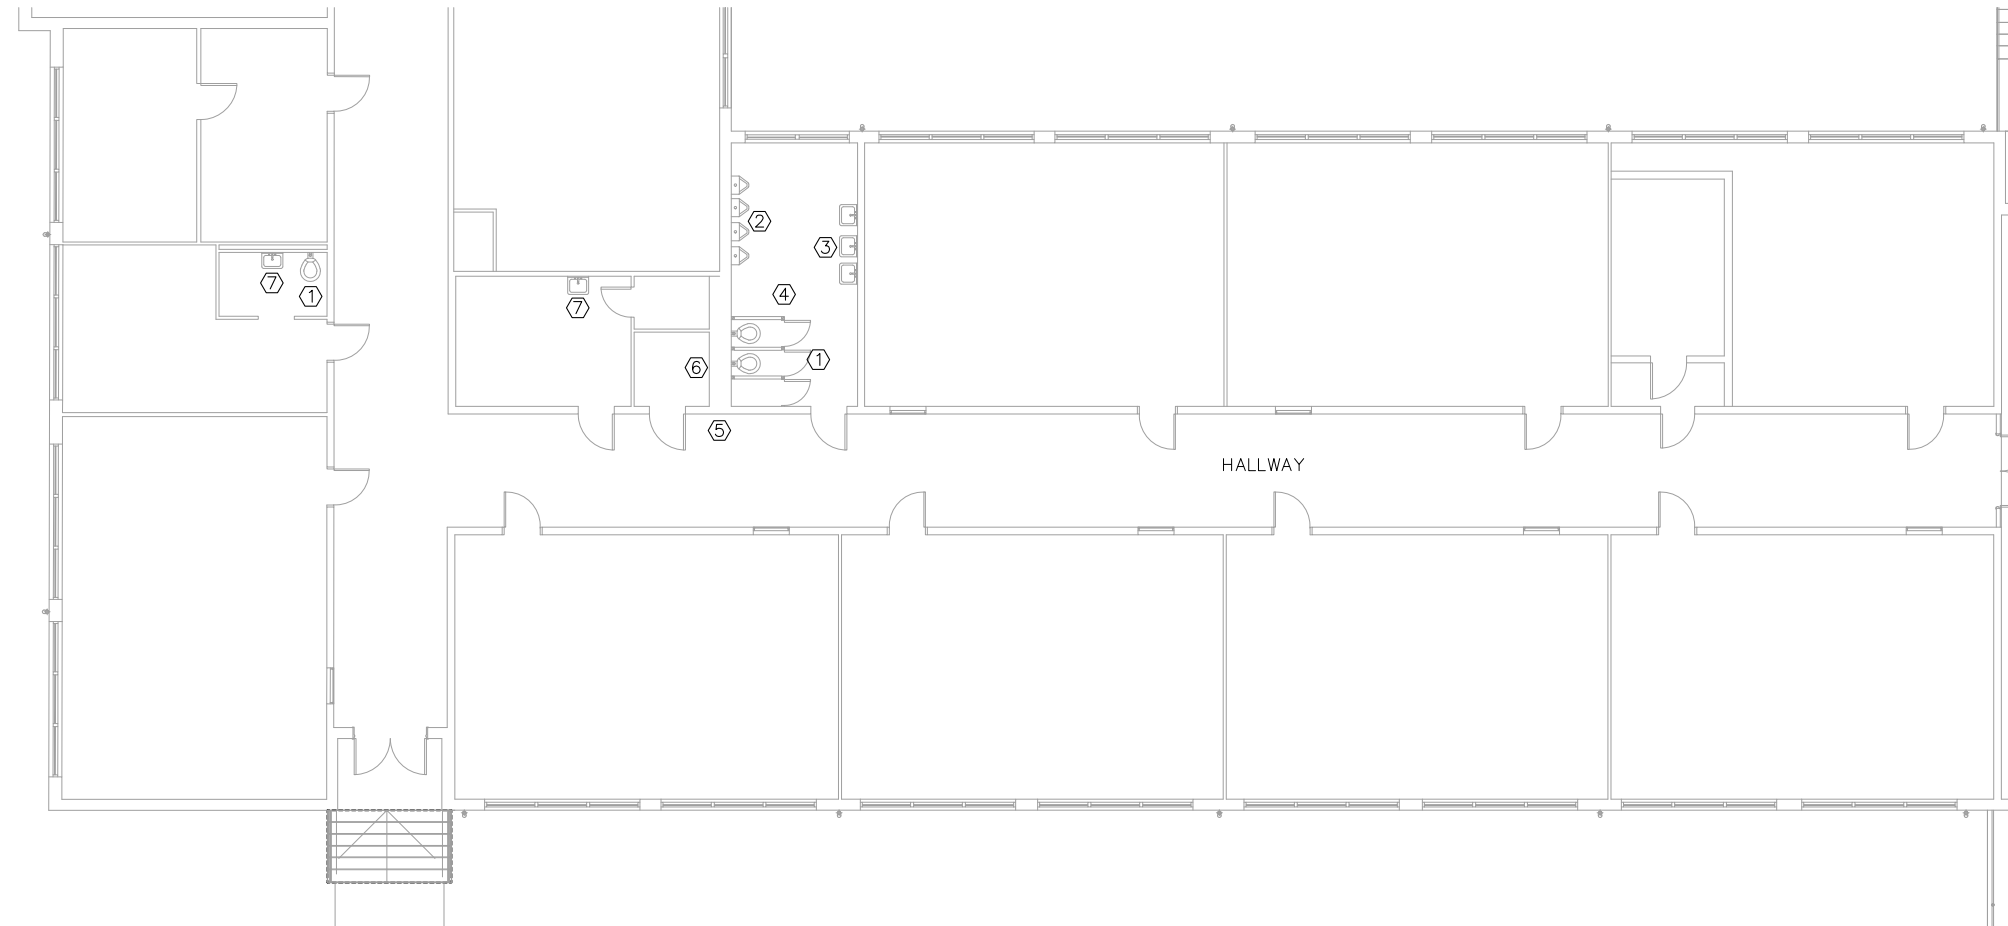
**CLASSROOM WING**  
SCALE: NTS

- ① FLOOR MOUNTED FLUSH VALVE TOILETS.
- ② WALL MOUNTED URINALS. THREE ARE MISSING.
- ③ WALL MOUNTED LAVATORIES TWO ARE MISSING.
- ④ BATHROOM FLOOR DRAIN RISES ABOVE EXISTING TILE FLOOR – TRIP HAZARD.
- ⑤ WALL MOUNTED DRINKING FOUNTAIN. (NON-ADA)
- ⑥ MOP SINK.
- ⑦ WALL MOUNTED LAVATORY.

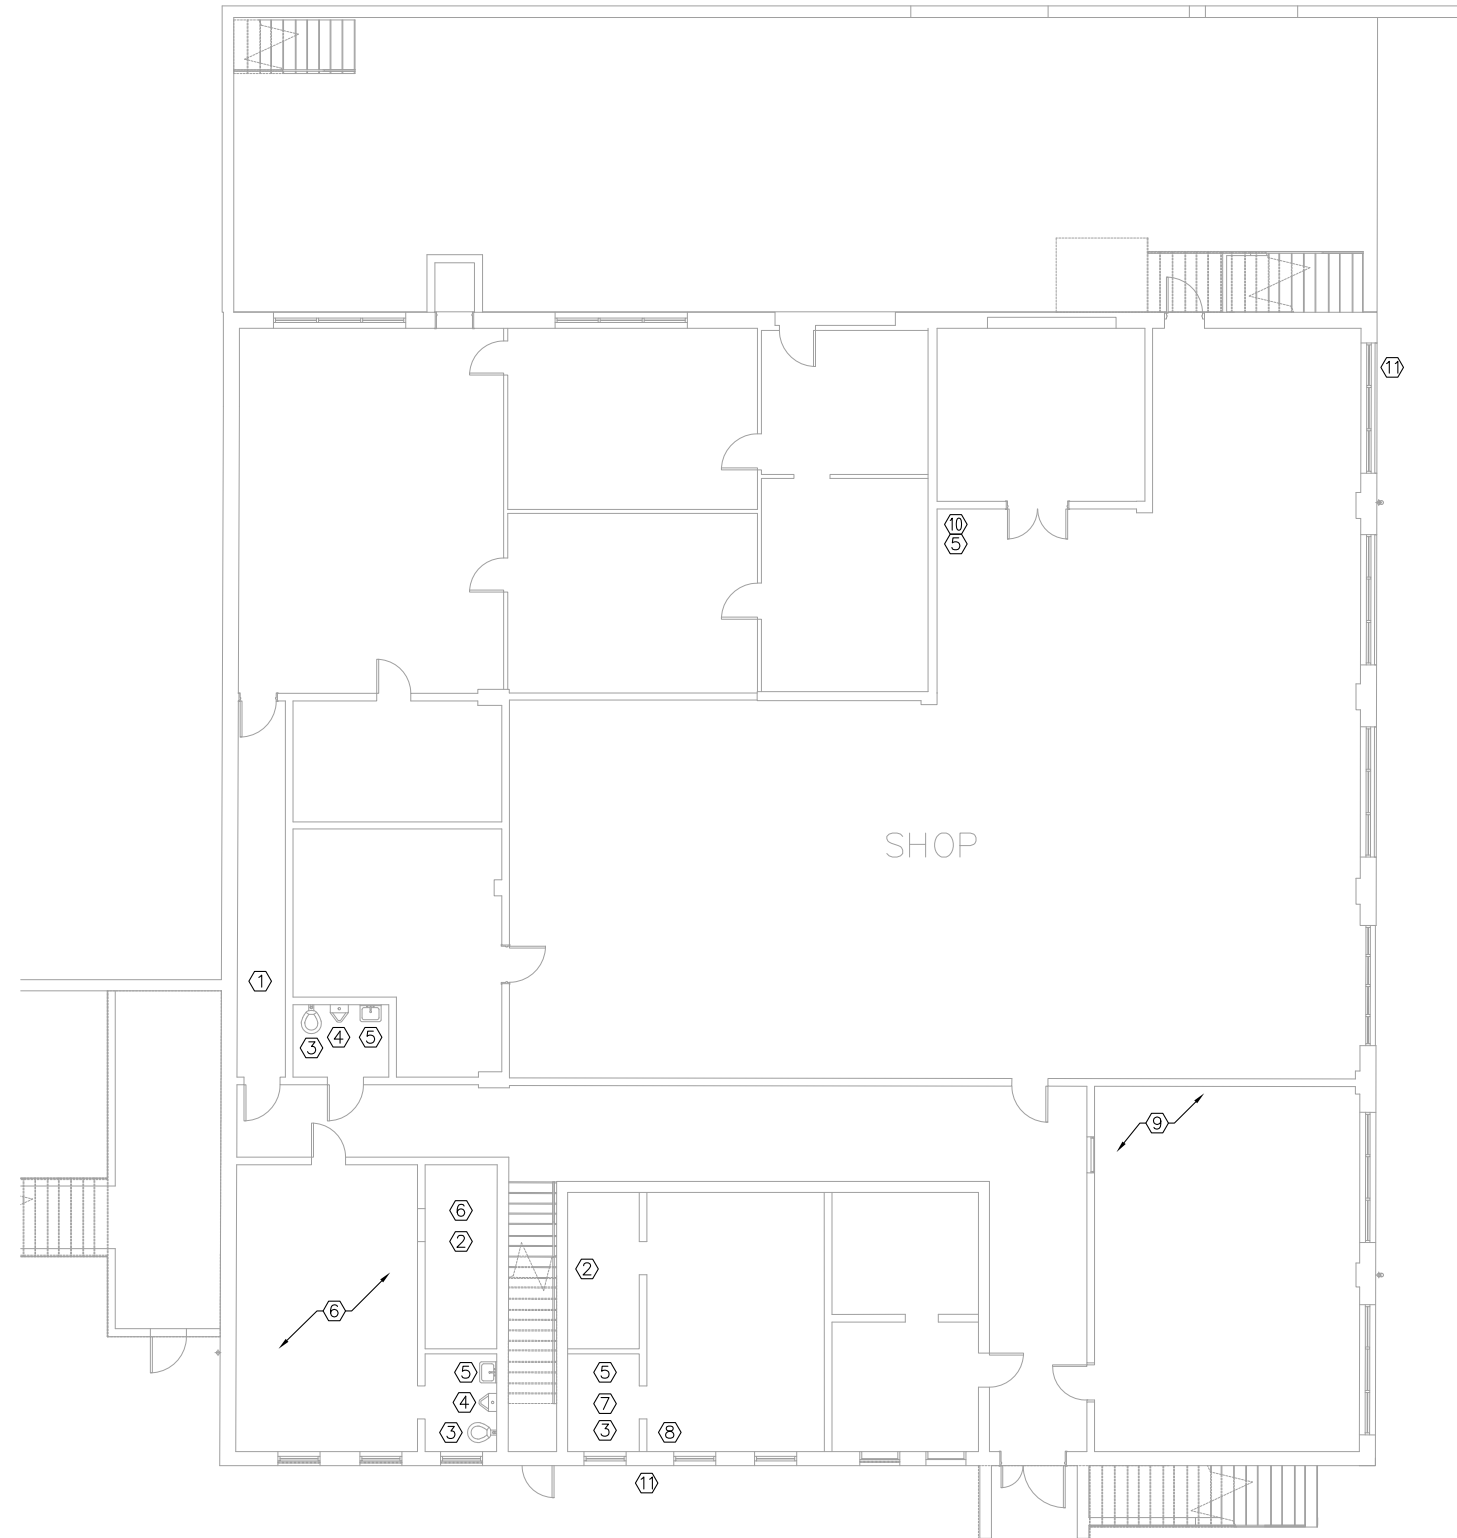
**GYM - LOWER LEVEL**  
SCALE: NTS

- KEYED NOTES (THIS SHEET ONLY)**
- ① WASTE CLEAN OUT, CAP ABOVE FINISHED CONCRETE FLOOR ELEVATION - TRIP HAZARD.
  - ② SHOWERS.
  - ③ FLOOR MOUNTED FLUSH VALVE TOILET.
  - ④ WALL MOUNTED FLUSH VALVE URINAL.
  - ⑤ WALL MOUNTED LAVATORY.
  - ⑥ CLOGGED FLOOR DRAINS - NEED TO BE CLEANED OUT.
  - ⑦ URINAL REMOVED.
  - ⑧ PAST WATER HEATER LOCATION - NOT INSTALLED.
  - ⑨ COMPRESSED AIR REGULATOR/QUICK CONNECTS.
  - ⑩ WALL MOUNTED WATER COOLER.
  - ⑪ GAS REGULATOR/METER.
